Adelaide Building & Property Inspections Pty Ltd

Per-purchase Inspection Report

Property address	2 Manly Circuit WEST LAKES SHORE SA 5020
Report prepared for	The Uniting Church In Australia Property Trust SA ADELAIDE SA 5000
Client's contact details	Mobile
Real estate agent's details	Name Company
Type of inspection report	Standard Inspection, Defect Only
Persons present	Agent's Representative
Weather conditions	Fine
Inspector	Vince Luppino, Bulding Inspector Building Work Contractor BLD 57644

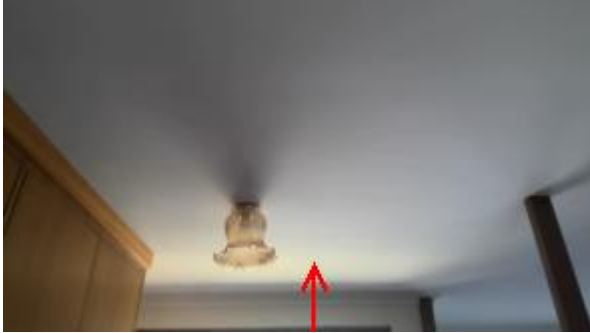
Further Investigation Type: A

Sagging has occurred to the ceiling, which has caused the nails to pop from the ceiling lining, and requires re-fixing and repainting. (Plasterboard fixer and Painter)

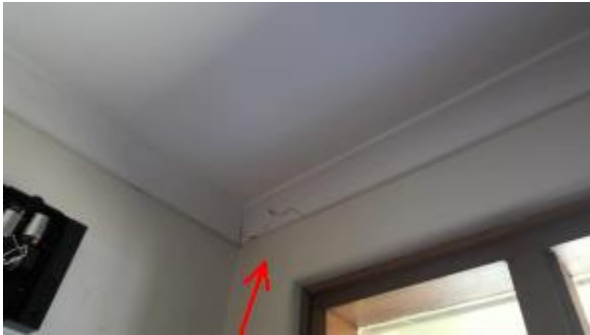
Damaged cornice

Minor Defect

Cornice has cracked and requires filling and repainting. (Painter)

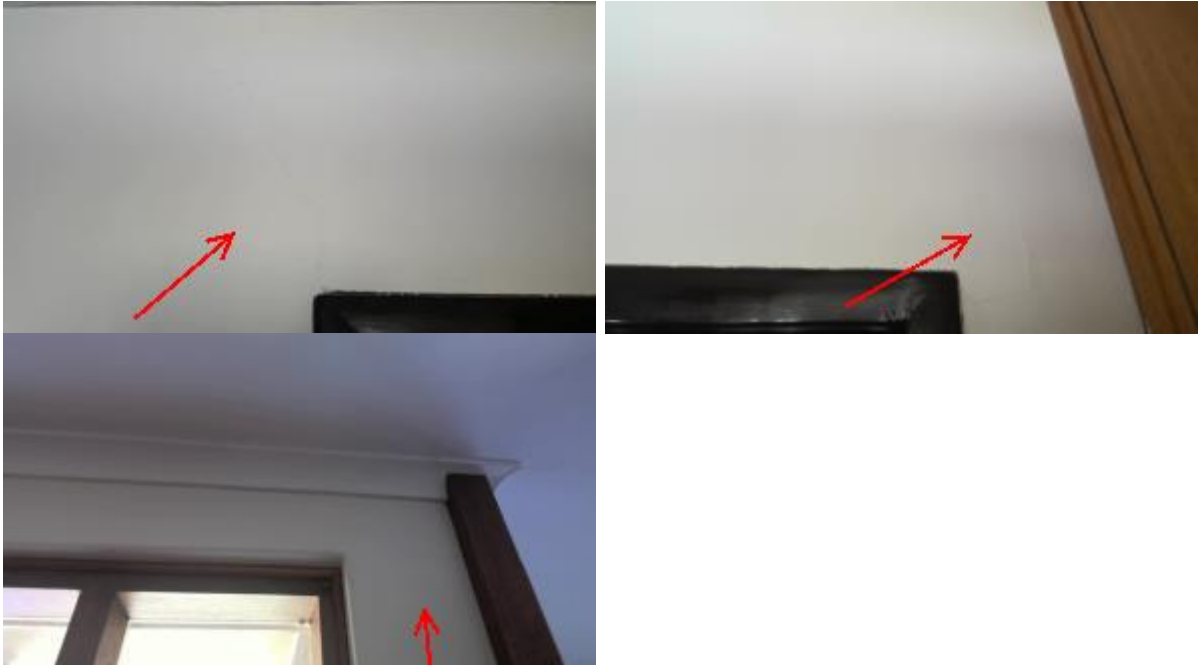
Cracking

Further Investigation Type: A

Cracking has occurred in the masonry wall above the door, which is can be common in this type of construction this type of cracking is typical movement that occurs in the walls and the foundations and it can be repaired although the cracking will continue to reoccur overtime. (Engineer and Plasterer)

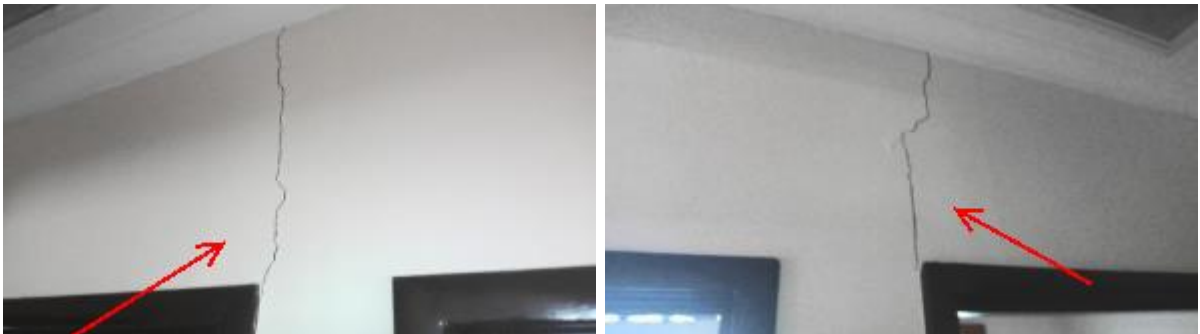
Cracking

Further Investigation Type: A

Cracking has occurred in the masonry wall above the door, which is can be common in this type of construction this type of cracking is typical movement that occurs in the walls and the foundations and it can be repaired although the cracking will continue to reoccur overtime. (Engineer and Plasterer)

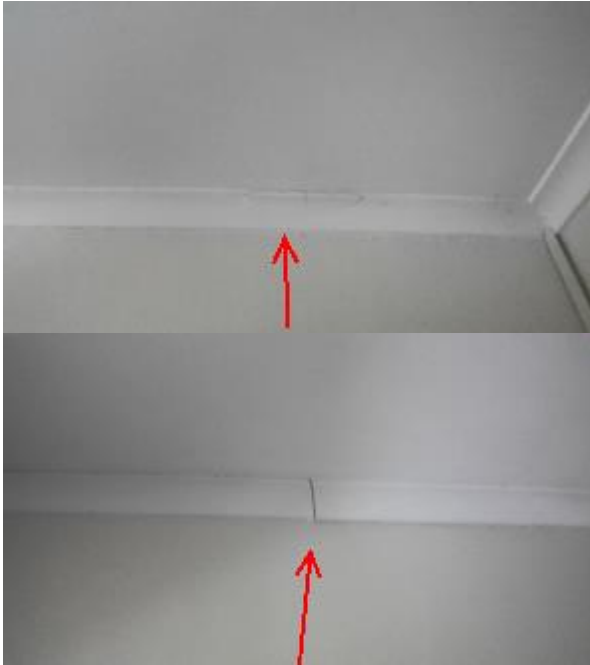
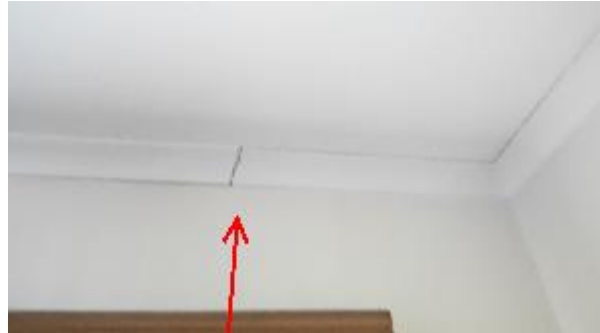
Damaged cornice

Minor Defect

Cornice has cracked and requires filling and repainting. (Painter)

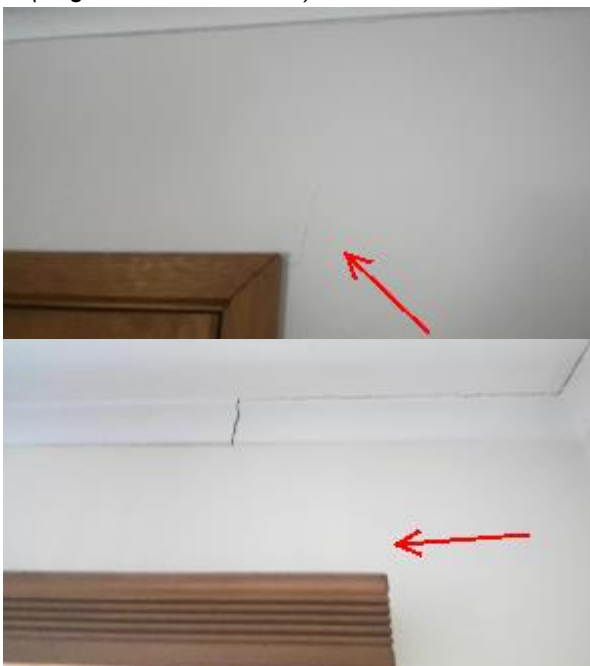
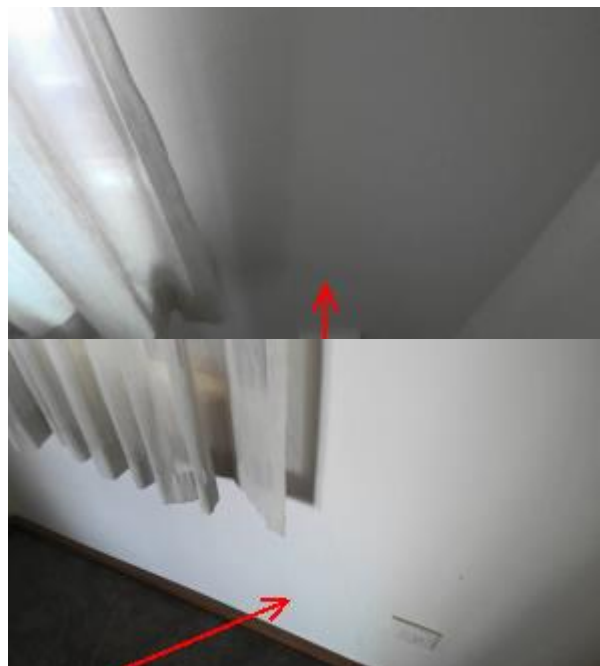
Cracking

Further Investigation Type: A

Cracking has occurred in the masonry wall adjacent to the door and the windows, which is can be common in this type of construction this type of cracking is typical movement that occurs in the walls and the foundations and it can be repaired although the cracking will continue to reoccur overtime. (Engineer and Plasterer)

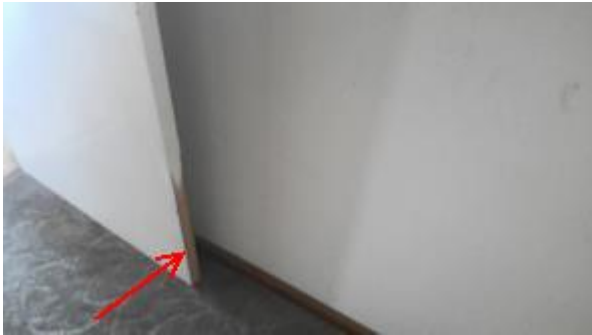
Doors and door frames Damaged doors
Door is damaged and requires repainting. (Painter)

Minor Defect Type: A

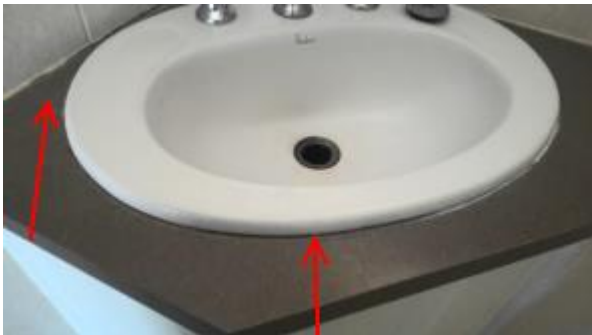
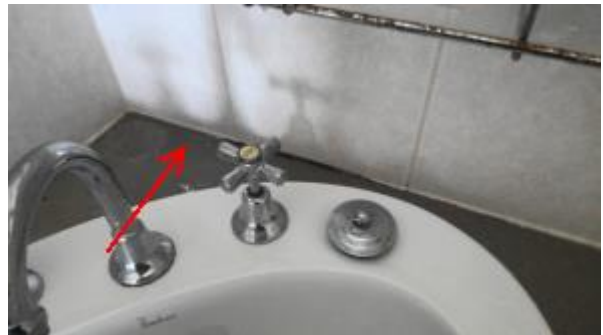
Bench top Defective sealant
Sealant between the bench top has mouldy and requires replacing. (Tiler)

Minor Defect Type: A

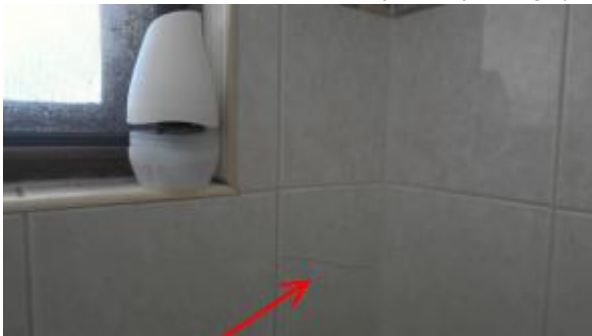
Wall tiles Cracked wall tiles
A wall tile has cracked, and require replacing. (Tiler)

Minor Defect Type: A

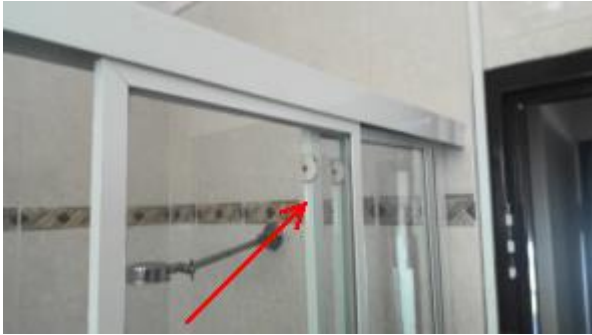
Shower screen Shower screen requires adjustment Major Defect Type: E
Shower screen is out of alignment and is not able to opened and closed and requires adjusting. (Glazier)

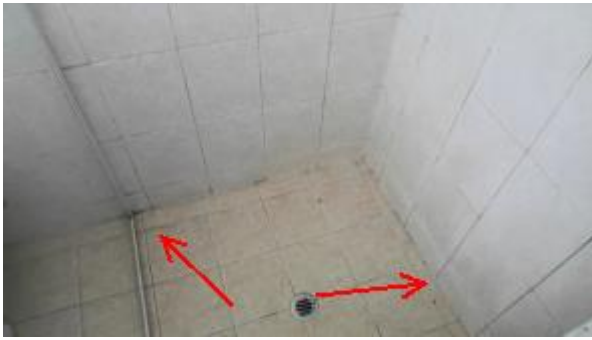
Shower tiles Mouldy sealant Minor Defect Type: A
Mouldy sealant between the junctions of wall and floor tiles in the shower area requires removal and replacing. (Tiler)

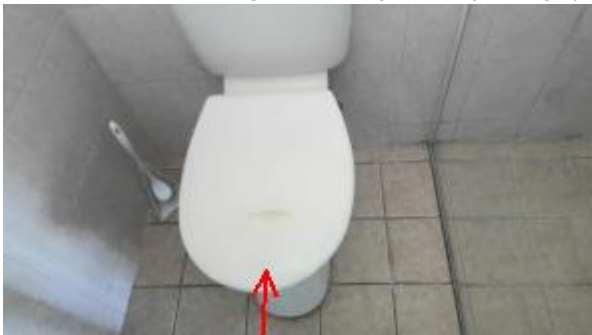
WC Pan Damaged toilet seat Minor Defect Type: A
Toilet seat is damaged and requires replacing. (Plumber)

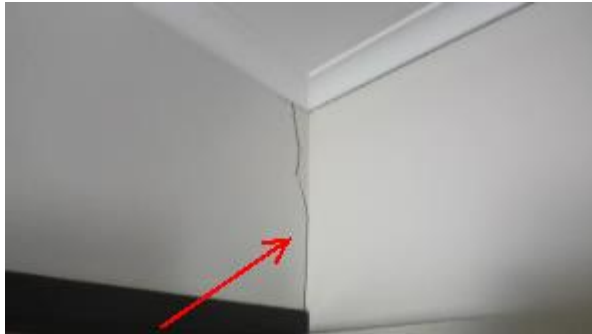
Cracking

Further Investigation Type: A

Cracking has occurred in the masonry wall in the internal corner, which is can be common in this type of construction this type of cracking is typical movement that occurs in the walls and the foundations and can be repaired although the cracking will continue to reoccur overtime. (Engineer and Plasterer)

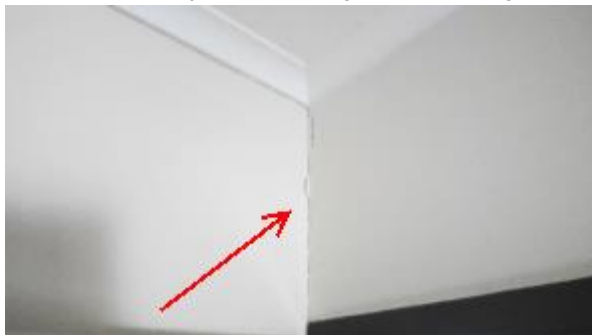
Cracking

Further Investigation Type: A

Cracking has occurred in the masonry wall in the internal corner, which is can be common in this type of construction this type of cracking is typical movement that occurs in the walls and the foundations and can be repaired although the cracking will continue to reoccur overtime. (Engineer and Plasterer)

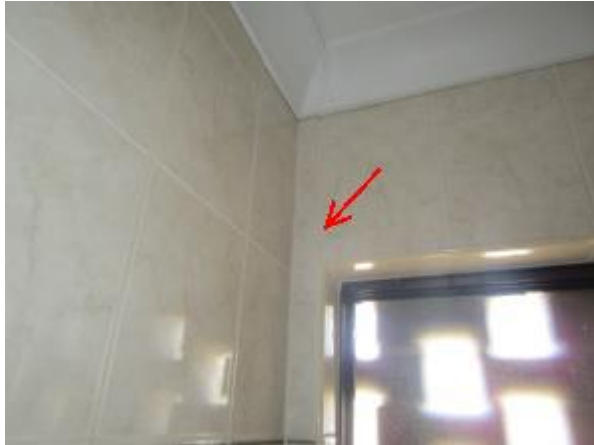
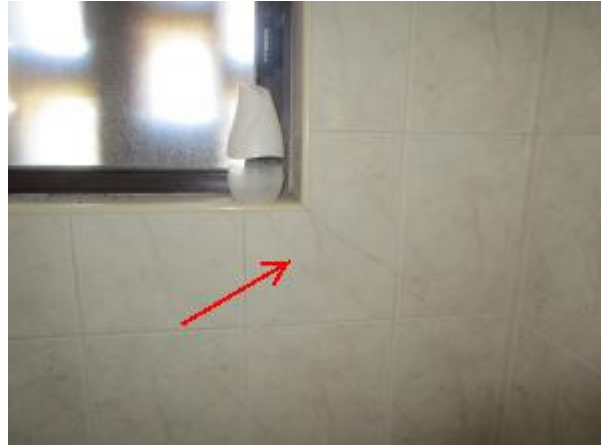
Wall tiles Cracked wall tiles Further Investigation Type: A
Two wall tile adjacent the window have cracked, and require replacing. (Tiler)

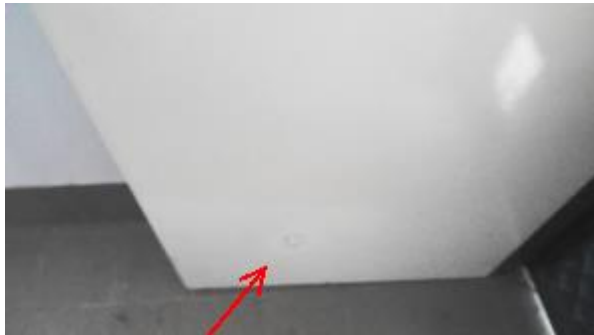
Doors and door frames Damaged doors Minor Defect Type: A
Door is damaged and requires repainting. (Painter)

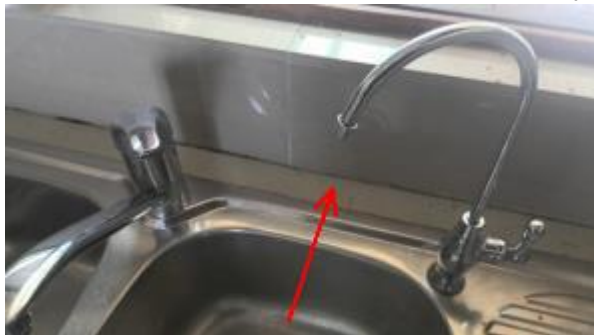
Bench top Defective sealant Minor Defect Type: F
Sealant between the wall tiles and the bench top has gapped and requires replacing. (Tiler)

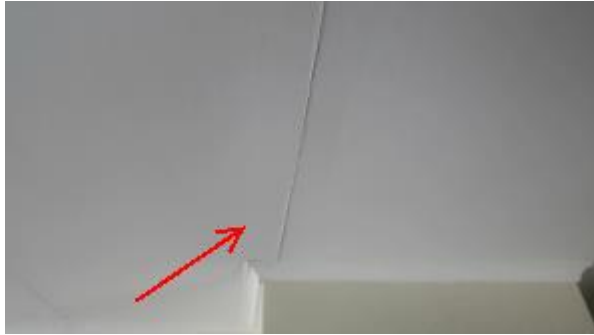
Cracking

Further Investigation Type: A

Ceiling has cracked on a sheet joint, and may require the installation of a expansion joint, which will allow flexibility and movement between the ceiling sheets and prevent further cracking. (Plasterboard flusher and Painter)

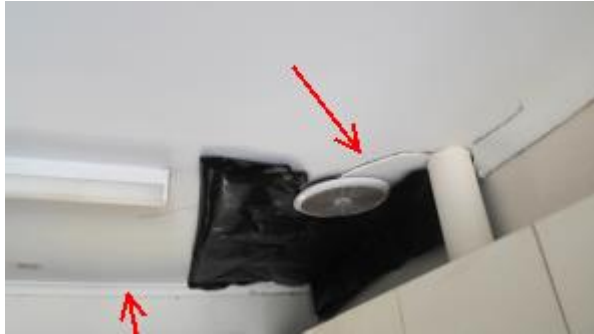
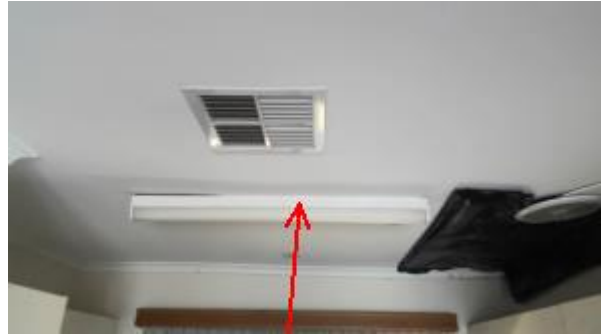
Damage ceiling

Further Investigation Type: A

Cracking has occurred on the ceiling surface, which has been previously repaired, which will requires replacing. (Ceiling fixer)

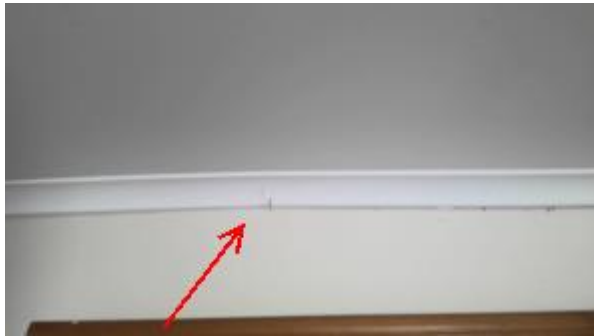
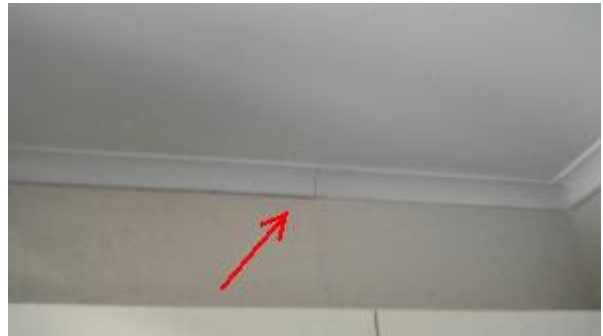
Damaged cornice

Minor Defect

Cornice has cracked and requires filling and repainting. (Painter)

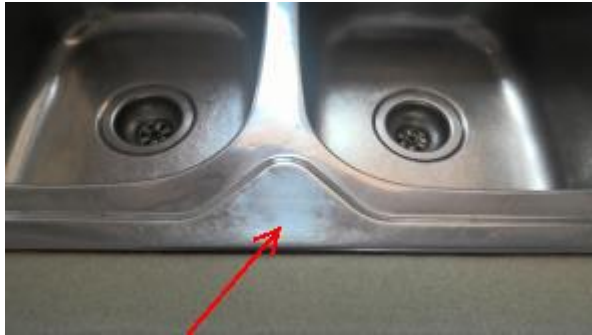
Damaged sink

Minor Defect

Sink is damaged and requires replacing. (Plumber)

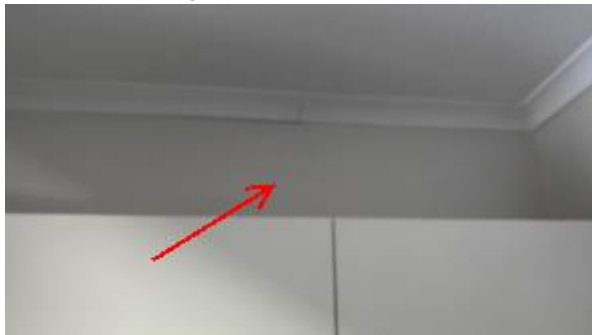
Cracking

Minor Defect

Minor cracking which has occurred to wall surface, which requires and filling and repainting. (Painter)

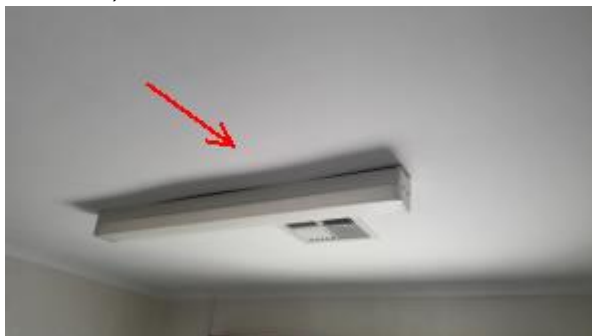
Minor Defect

Sagging has occurred to the ceiling, which requires re-fixing, filling and repainting. (Ceiling fixer & Painter)

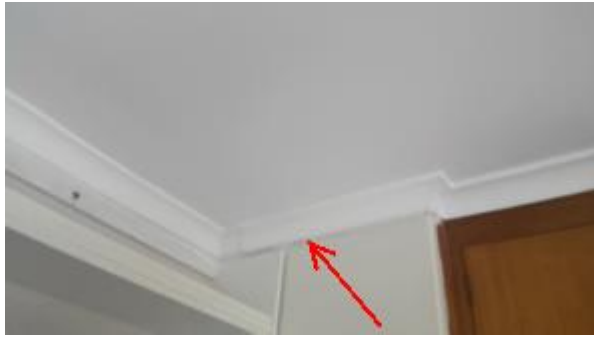
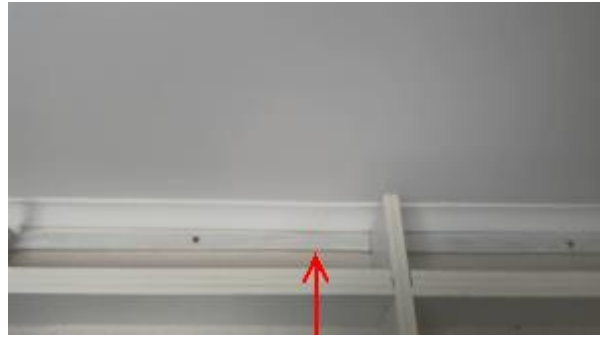
Damaged cornice

Minor Defect

Cornice has cracked and requires filling and repainting. (Painter)

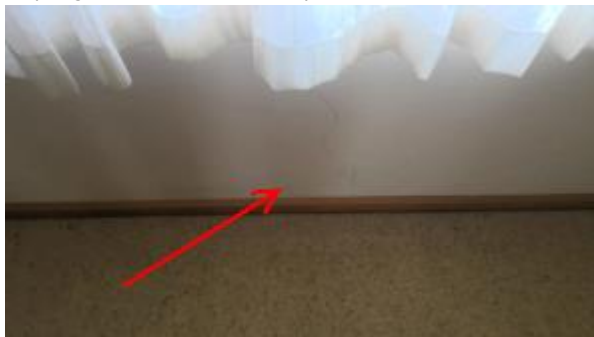
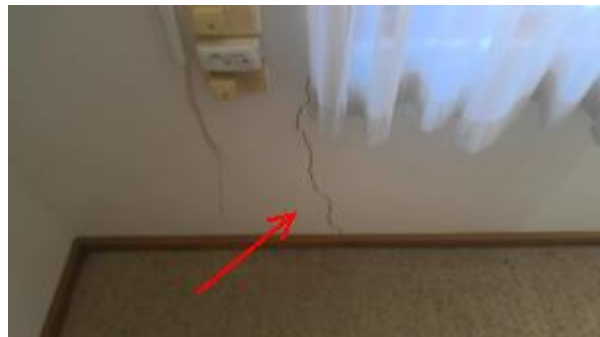
Cracking

Further Investigation Type: A

Cracking has occurred in the masonry wall adjacent to the window and the door, which is can be common in this type of construction this type of cracking is typical movement that occurs in the walls and the foundations and it can be repaired although the cracking will continue to reoccur overtime. (Engineer and Plasterer)

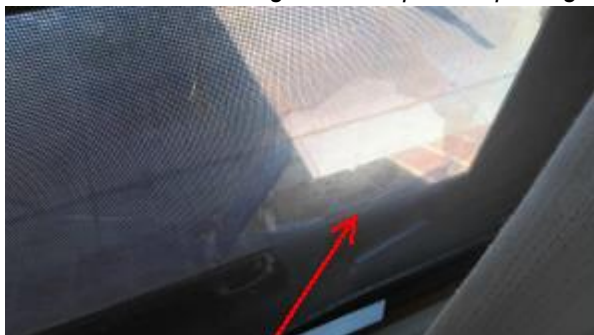
Minor Defect

Window film is damaged and requires replacing. (Window manufacturer)

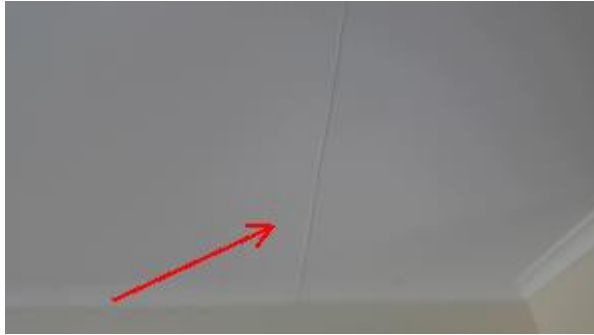
Ceilings Cracked ceiling Minor Defect Type: A

Ceiling has split on a sheet joint, which is common and requires filling and repainting. (Painter)

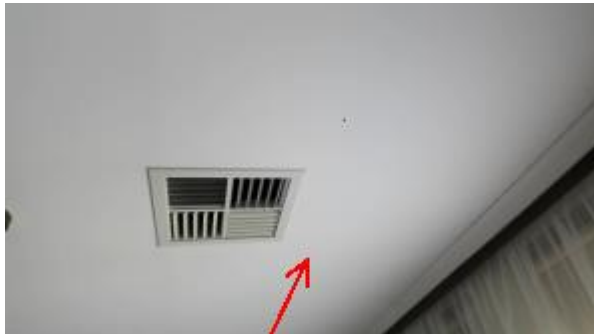
Ceilings Nails popping Minor Defect Type: A

Sagging has occurred to the ceiling, which has caused the nails to pop from the ceiling lining, and requires re-fixing and repainting. (Plasterboard fixer and Painter)

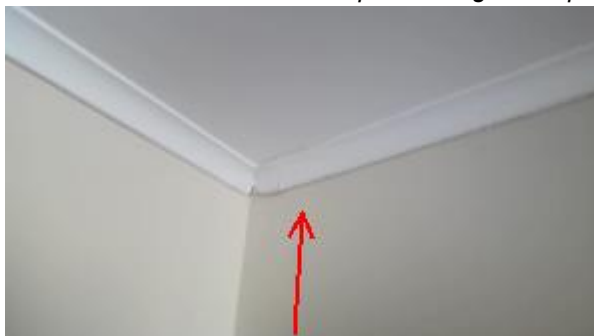
Cornice Damaged cornice Minor Defect Type: A

Cornice has cracked and requires filling and repainting. (Painter)

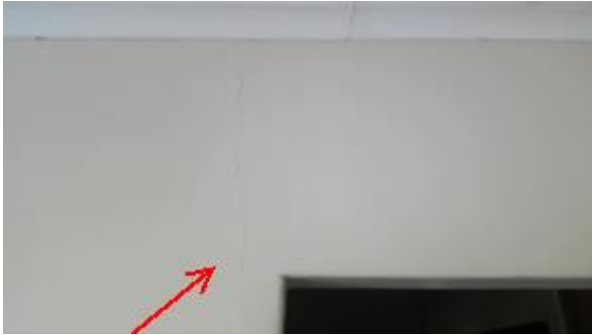
Cracking

Minor Defect

Minor cracking has occurred to the wall surface above the opening, which requires filling and repainting. (Painter)

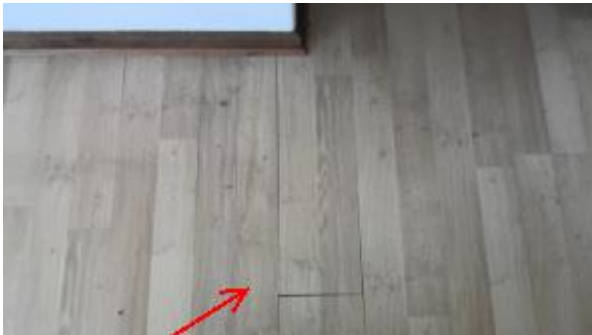
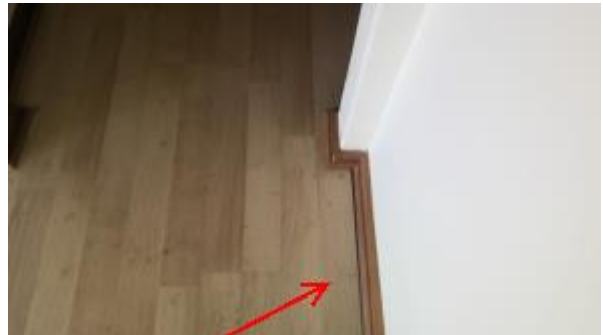
Damaged floor

Minor Defect

Laminate flooring is damaged and requires repairing. (Floor installer)

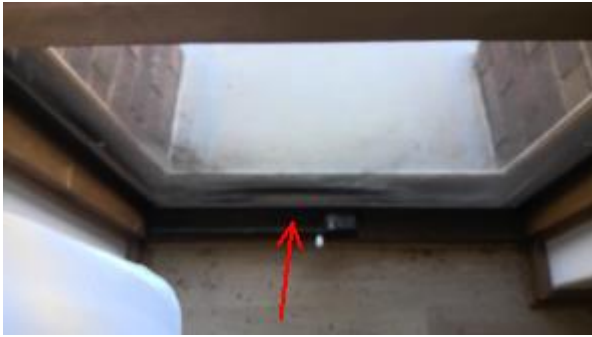
Windows Sash fittings and hardware Minor Defect Type: A
Fly wire is damaged and requires replacing. (Window manufacturer)

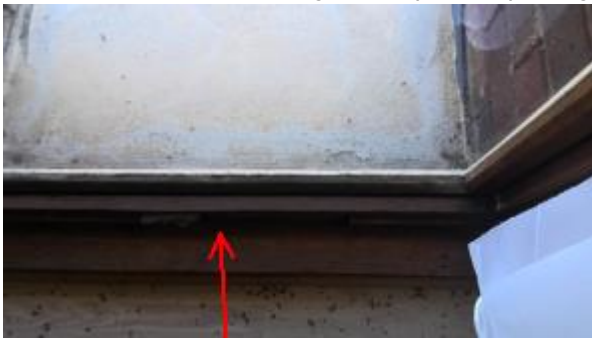
Windows Sash operation Minor Defect Type: E
Window winder is missing and requires replacing. (Window manufacturer)

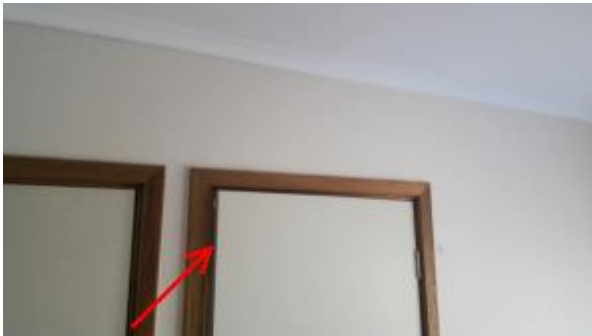
Doors and door frames Door not closing Minor Defect Type: E
Door is not closing correctly and requires adjusting. (Carpenter)

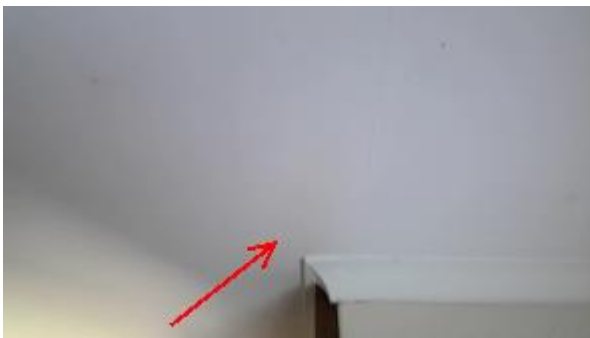
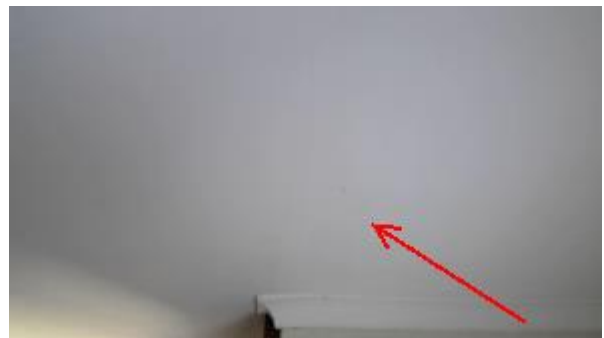
Damage ceiling

Minor Defect

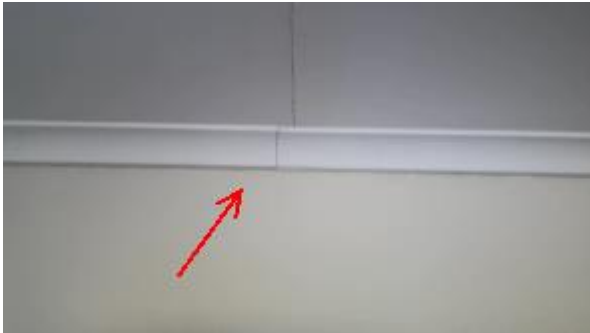
Damaged cornice

Minor Defect

Cornice has cracked and requires filling and repainting. (Painter)

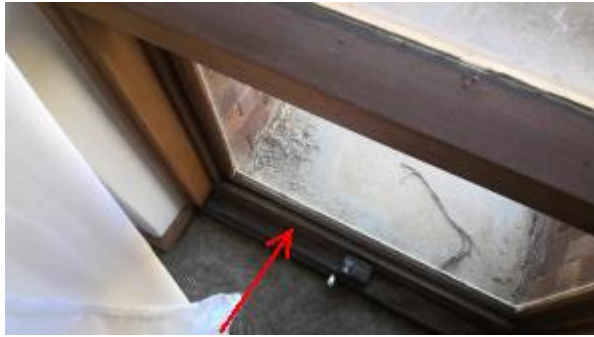
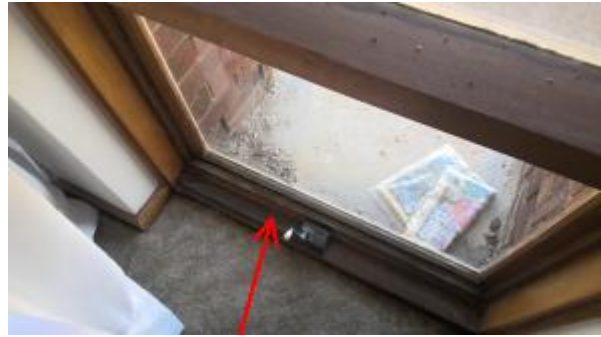
Windows Sash fittings and hardware Minor Defect Type: F
Fly screens are missing and require replacing. (Window manufacturer)

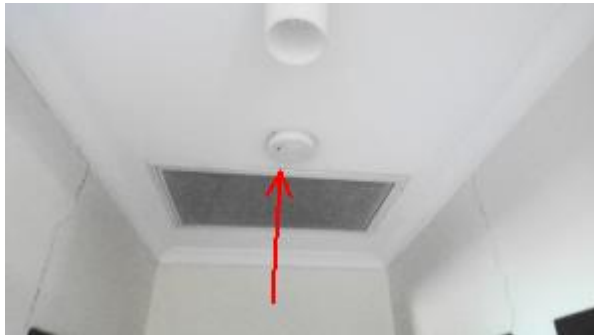
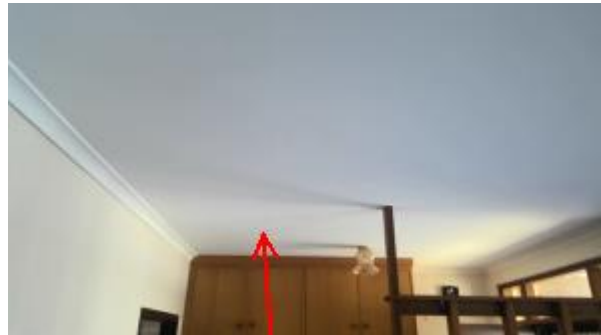
Smoke detector requires upgrading Smoke detector requires replacing Safety Hazard Type: F

Smoke alarm was present at the time of the inspection, and should be checked for the correct location of the smoke alarm. (Electrician)

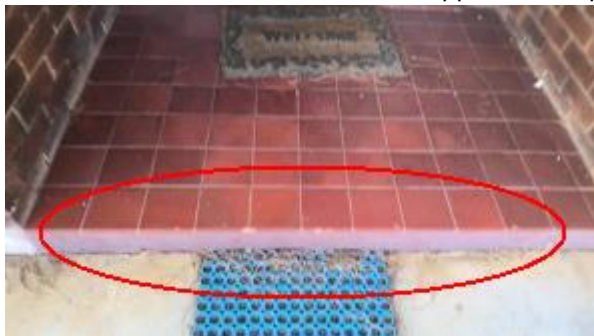
Patio or verandah Chipped tiling Minor Defect Type: A

Floor tiles on the verandah have chipped and require replacing. (Tiler)

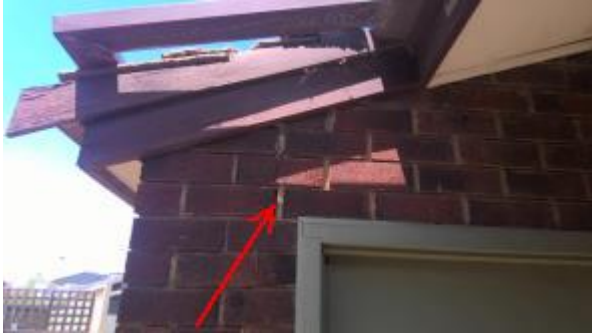
Cracking

Further Investigation Type: A

Cracking has occurred in the wall surface above the door and is related to wall and foundation movement, which is also common for the age and construction of the building. The cracking has developed over many years, and now has become an inherent weakness in the wall. The wall will continue to crack at this location and will require continue repairing. (Engineer and Bricklayer)

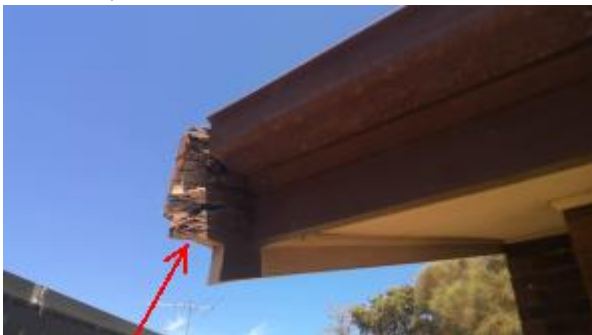
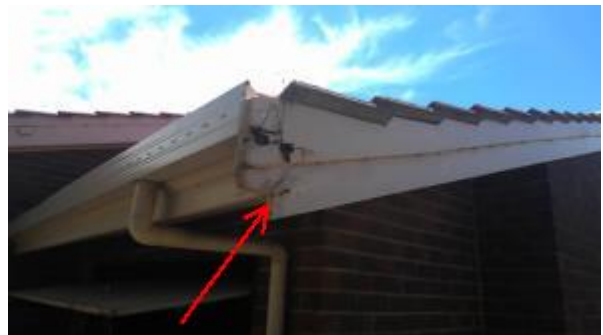
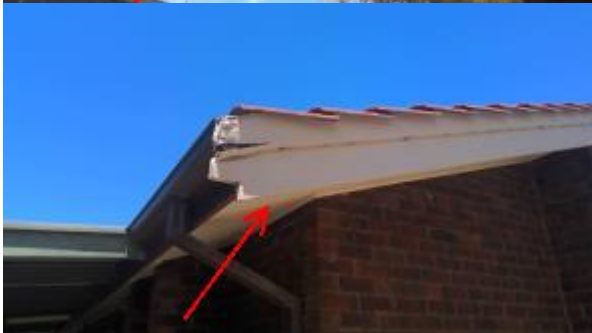
Decayed barge

Further Investigation Type: A

The end of the timber barge has decayed and require repairing and repainting. (Carpenter and Painter)

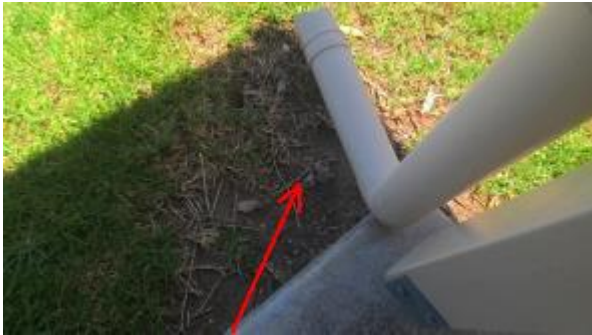
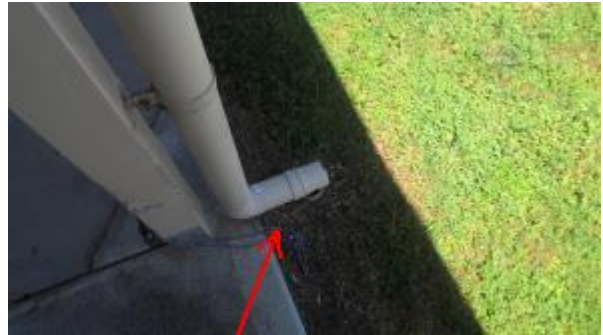
Damaged connection to storm water system

Minor Defect

Downpipe has been disconnected from the stormwater system and requires reconnecting to the stormwater to keep the discharge of water away from the edge of the building. (Roof plumber)

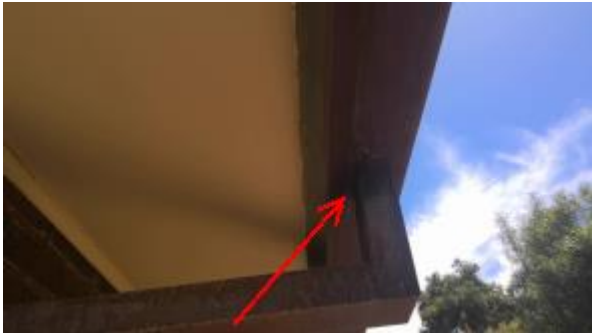
Corrosion in gutters

Minor Defect

Gutter has corroded and require replacing. (Roof plumber)

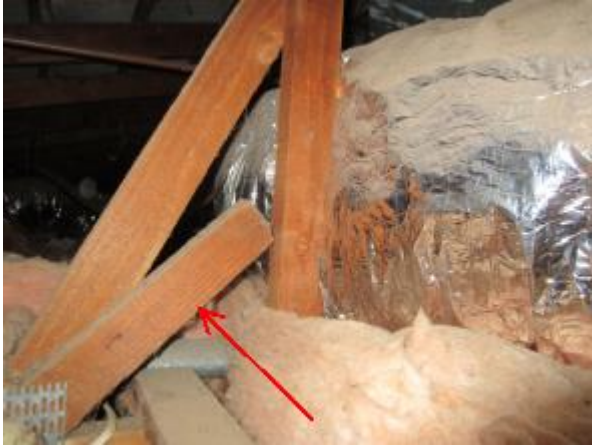
Damaged roof frame

Further Investigation Type: A

Roof truss has been cut, and will require repairing, as the roof truss can support a large amounts of the roof load and is designed to transfer the load to the external walls it will require repairing. This will require inspection from a timber engineer and detailed report for the repair of the roof truss. (Timber engineer and Carpenter)

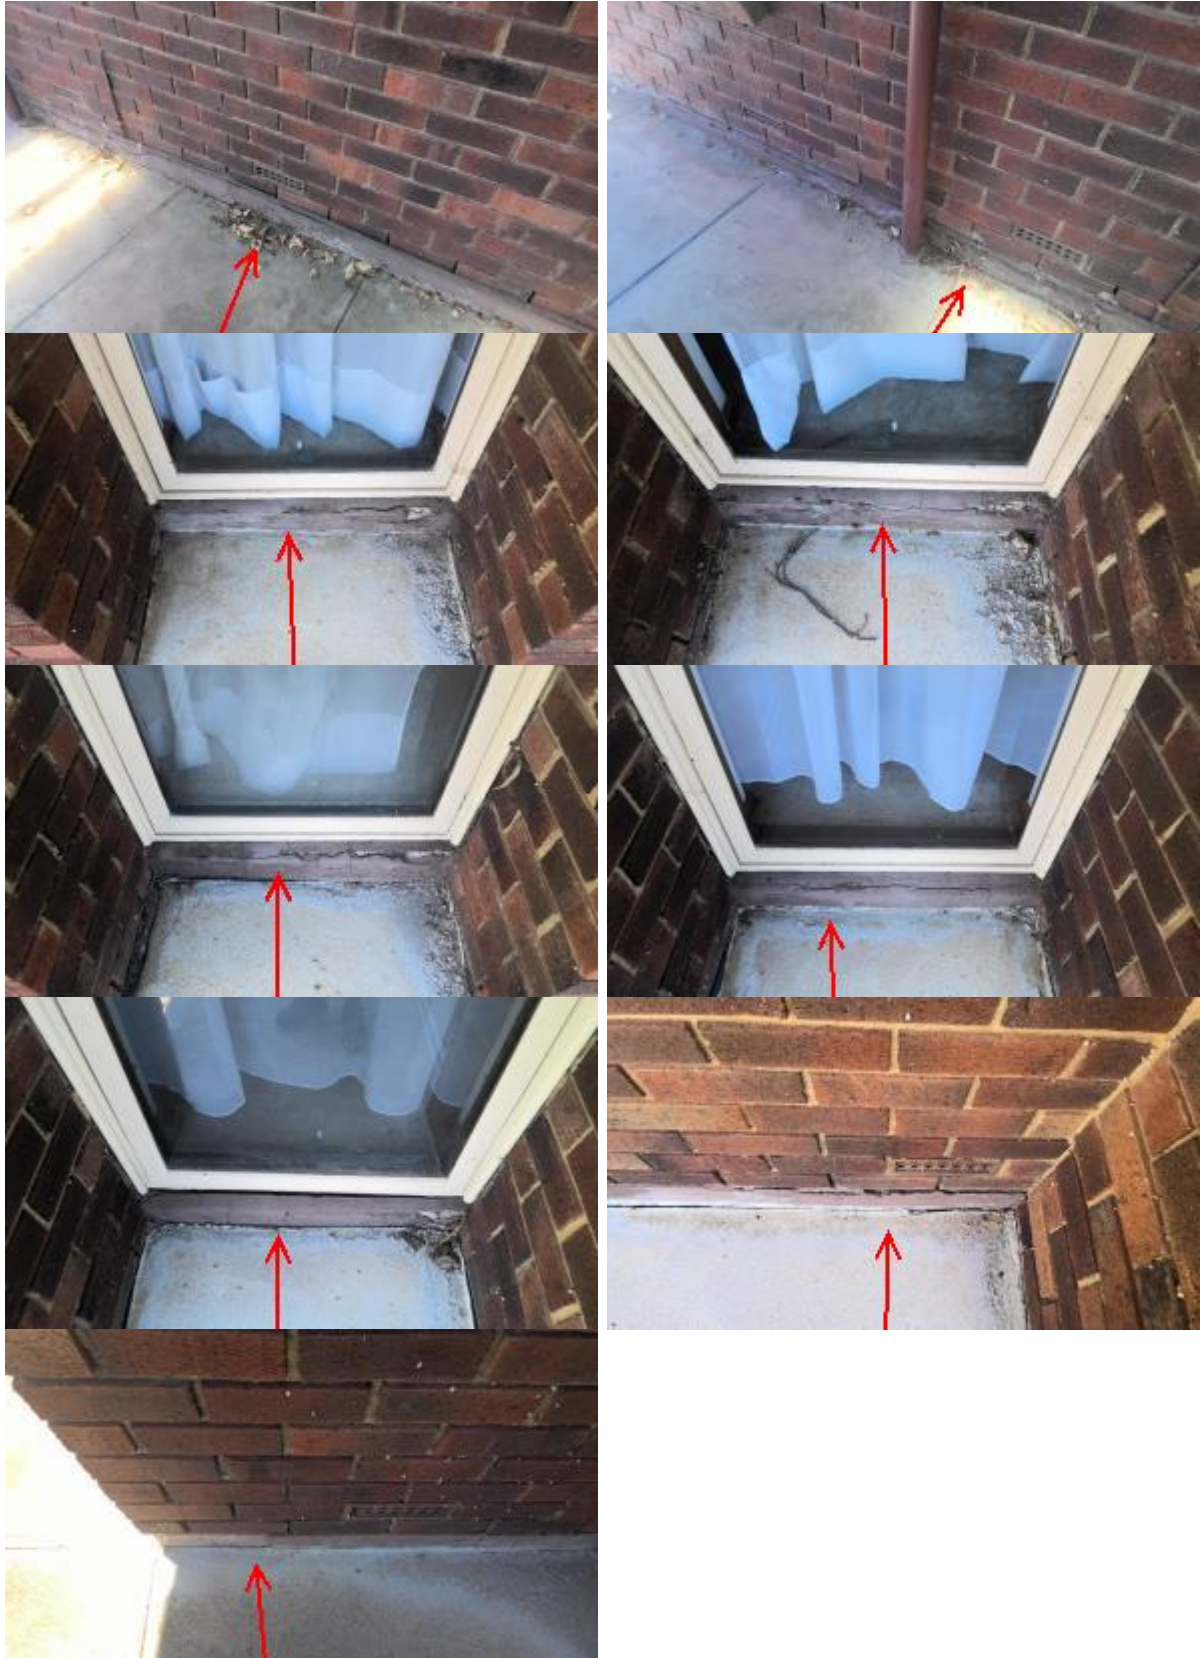
Cracking evident in footing edges

Minor Defect

Plastered on the edges of the foundation is damaged and requires repairing the loose plaster should be removed and re-plaster. (Plasterer)

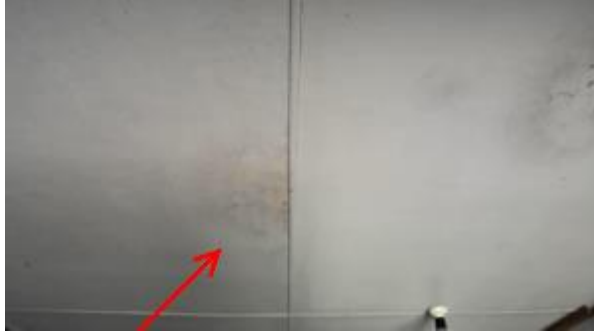
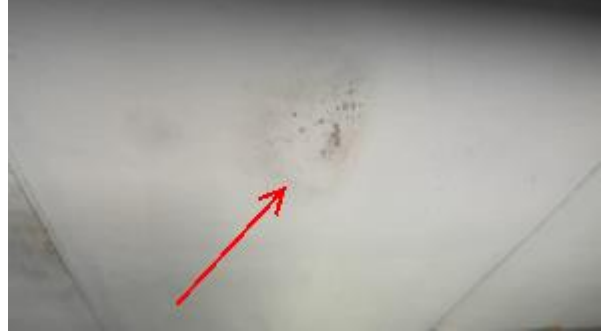
Dampness damage

Mould is visible on the ceiling surface of the garage this is caused by rood leaking and the ceiling should be professionally cleaned and repainted to prevent the further spread of the mould spores. (Cleaners and Painter)

NB: Mould can be a serious health risk for people with health issues, to prevent the spread of mould spores it requires regular maintenance and may require advice from your local council or government health department.

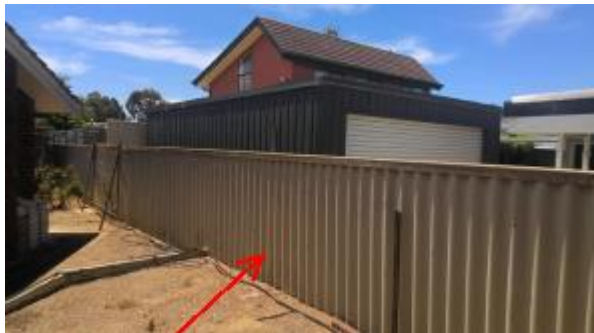
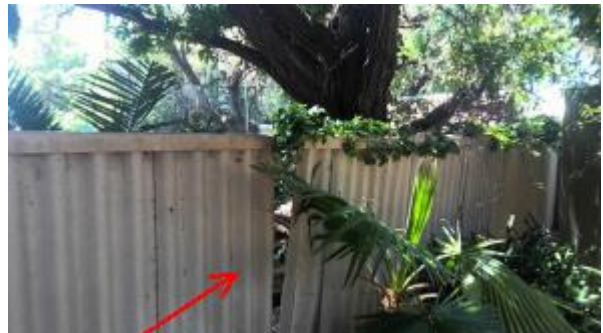
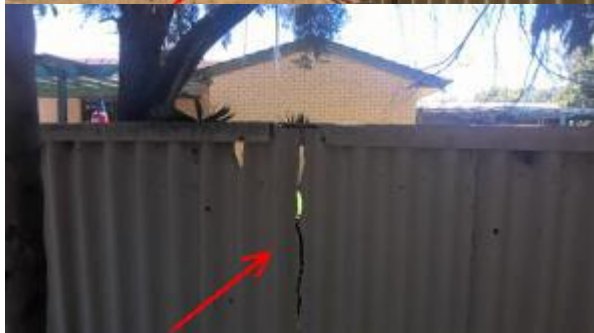
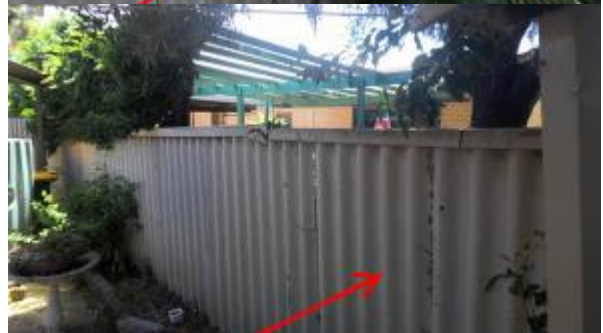
Boundary fence appears to be asbestos and requires conformation of the material, and about one third of homes built in this period used asbestos containing products. There's negligible risk in living in these homes, if undisturbed asbestos containing products are safe because the asbestos fibres are bound together in a solid matrix. But if they are tooled, cut, drilled, sanded or otherwise abraded or machined they can release asbestos fibres into the air.

Unfortunately, through ignorance, many home renovators, home maintenance and building workers don't realise the dangers of exposure and may only learn of it if at all once the building work is finished. Prolonged exposure, where the building work goes on for months or years, carries the greatest risk. For home renovators, a brief one-off exposure is very low risk. (Asbestos consultant)

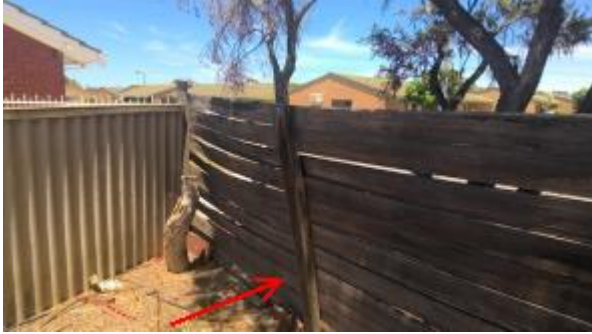
Decayed fencing

Minor Defect

Boundary fence has decayed, and requires replacing. (Fencing contractor)

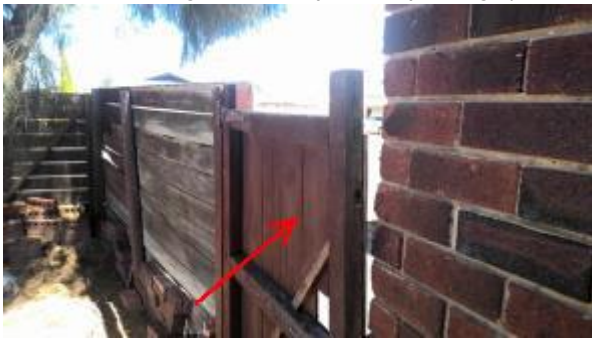
Damaged gate

Minor Defect

Gate is damaged and requires replacing. (Fencing contractor)
