# Adelaide Building & Property Inspections Pty Ltd

# Per-purchase Inspection Report

Prepared within the limitations and conditions specified in  
Australian Standard AS 4349.1 - 2007 Pre-purchase Inspections - Residential buildings - Appendix C

Property address	22 Yeltana Avenue WATTLE PARK SA 5066
Report prepared for	Paul McGrath ADELAIDE SA 5000
Client's contact details	Mobile 0413 001 211 paulmcgrath@mcgrathgroup.com.au
Real estate agent's details	Name Paul Company McGrath Real Estate
Type of inspection report	Standard Inspection, Defect Only
Persons present	Vendor, Tenant
Weather conditions	Fine
Inspector	Vince Luppino, Bulding Inspector Building Work Contractor BLD 57644

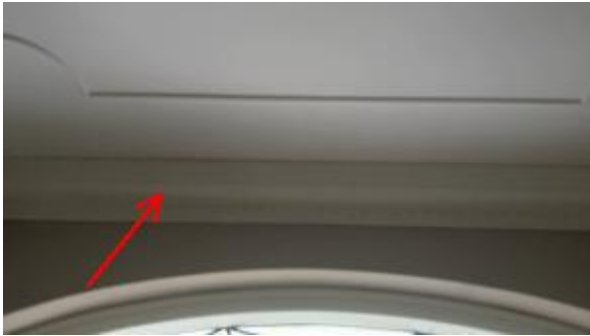
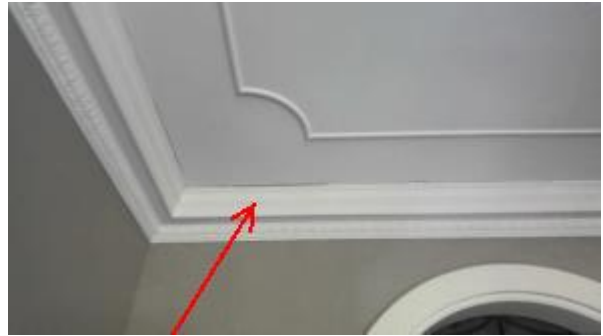
*Cornice has gapped from the ceiling surface, which is common and relates to minor movement and requires refilling and repainting. (Painter)*

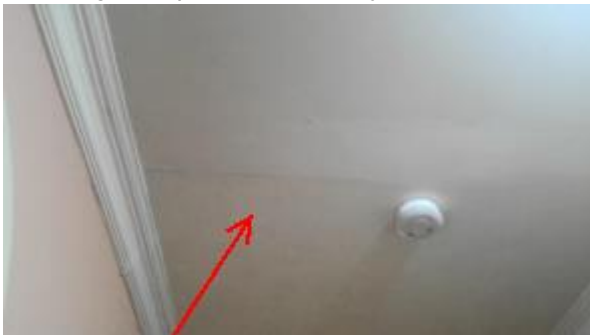
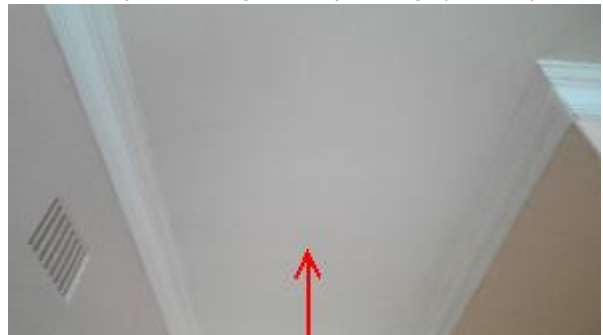
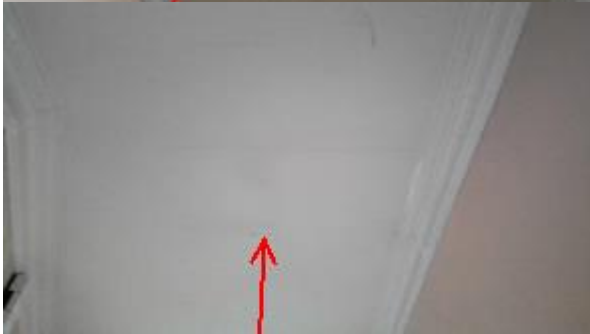
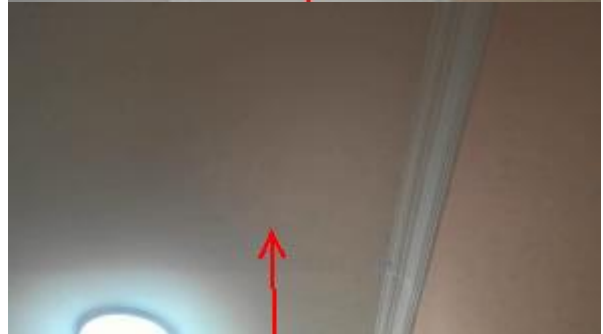
Cracked ceiling

*Ceiling has split on two sheet joins which is common and requires filling and repainting. (Painter)*

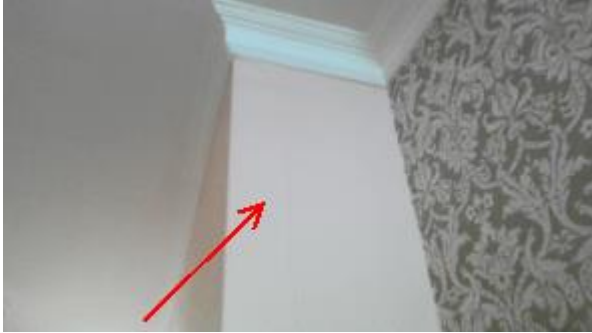
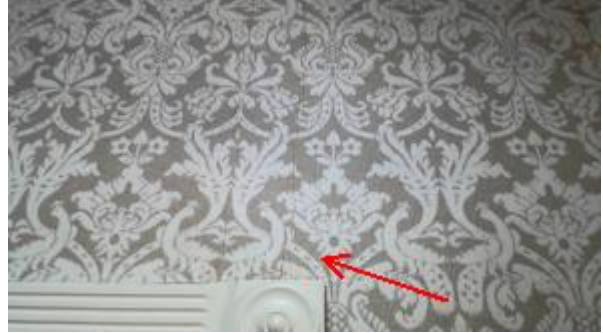
*Cracking has occurred in the masonry wall, which is can be common in this type of construction this type of cracking is typical movement that occurs in the walls and the foundations and it can be repaired although the cracking will continue to reoccur overtime. (Engineer and Plasterer)*

Cracking has occurred in the masonry wall, which is can be common in this type of construction this type of cracking is typical movement that occurs in the walls and the foundations and it can be repaired although the cracking will continue to reoccur overtime. (Engineer and Plasterer)

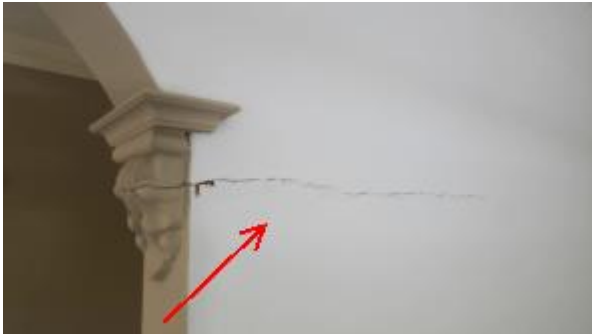
*Cracking has occurred in the masonry wall adjacent the arched opening, which is can be common in this type of construction this type of cracking is typical movement that occurs in the walls and the foundations and it can be repaired although the cracking will continue to reoccur overtime. (Engineer and Plasterer)*

Cracking has occurred in the masonry wall adjacent the arched opening, which is can be common in this type of construction this type of cracking is typical movement that occurs in the walls and the foundations and it can be repaired although the cracking will continue to reoccur overtime. (Engineer and Plasterer)

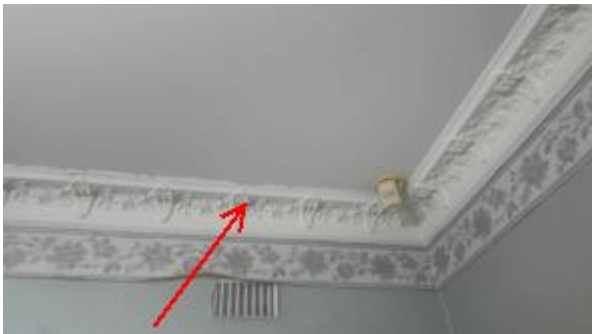
Damaged cornice

*Cornice has cracked and requires filling and repainting. (Painter)*

Cornice has cracked and requires filling and repainting. (Painter)

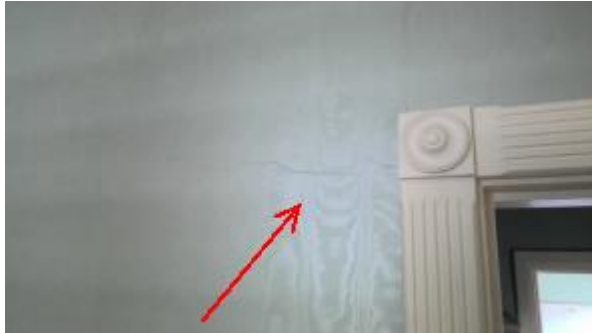
*Cracking has occurred in the masonry wall adjacent to the door, which is can be common in this type of construction this type of cracking is typical movement that occurs in the walls and the foundations and it can be repaired although the cracking will continue to reoccur overtime. (Engineer and Plasterer)*

Cracking has occurred in the masonry wall adjacent to the door, which is can be common in this type of construction this type of cracking is typical movement that occurs in the walls and the foundations and it can be repaired although the cracking will continue to reoccur overtime. (Engineer and Plasterer)

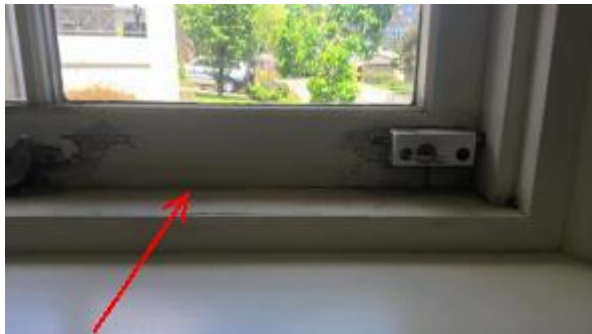
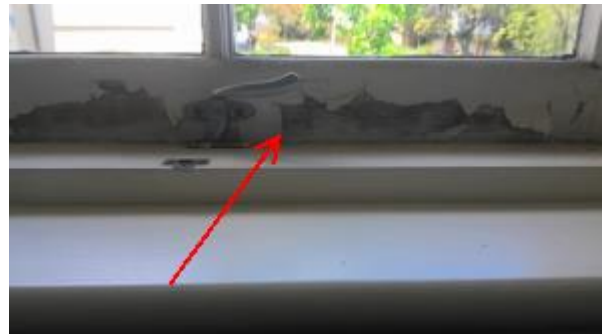
Decayed frames and sashes

*Window frame and sashes have deteriorated because of lack of maintenance and requires repairing and repainting. (Painter)*

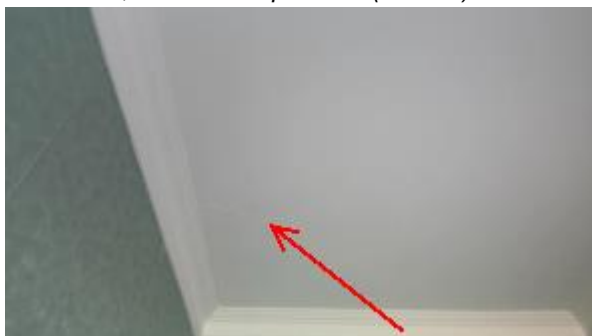
*Paint has flaked from the ceiling, which requires all the loose paint to be scraped off, and the ceiling cleaned, filled and repainted. (Painter)*

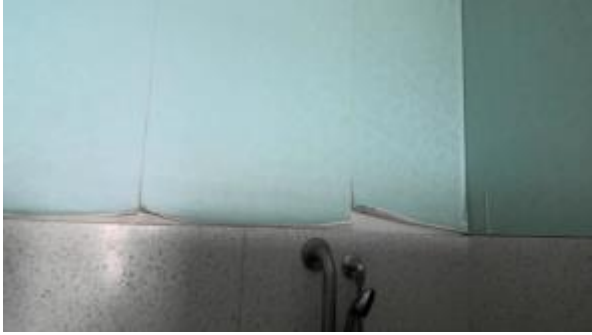
Wallpaper peeling

*Wall paper has peeled from the wall surface and should be removed and the walls repainted. (Painter)*

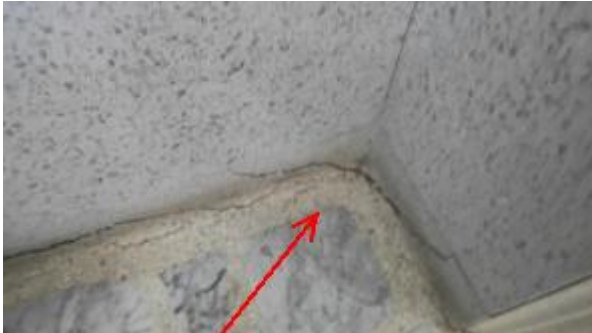
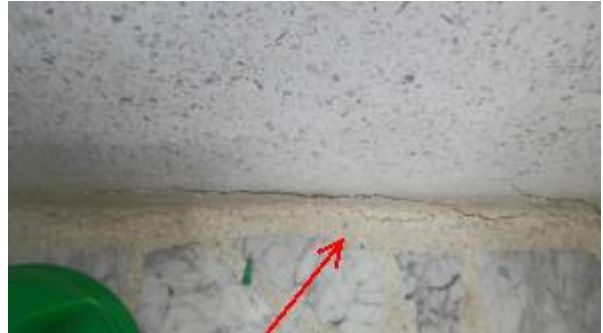
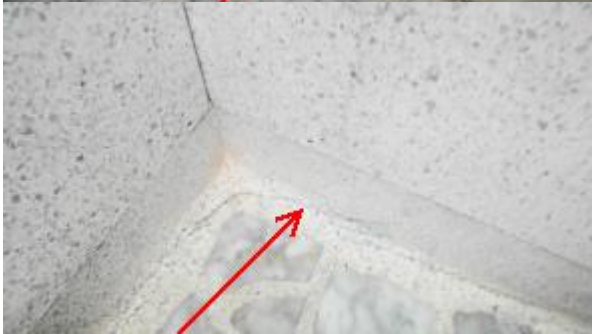
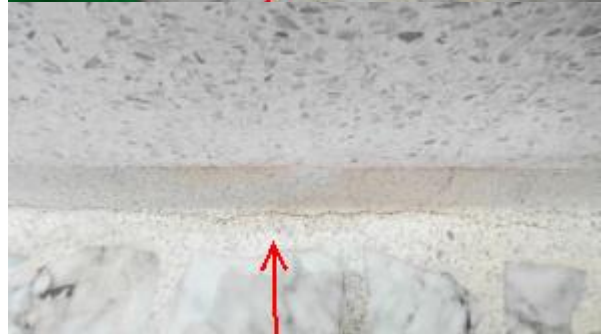
Surface damage

*Terrazzo floor has cracked and requires repairing. (Concreter)*

Terrazzo floor has cracked and requires repairing. (Concreter)

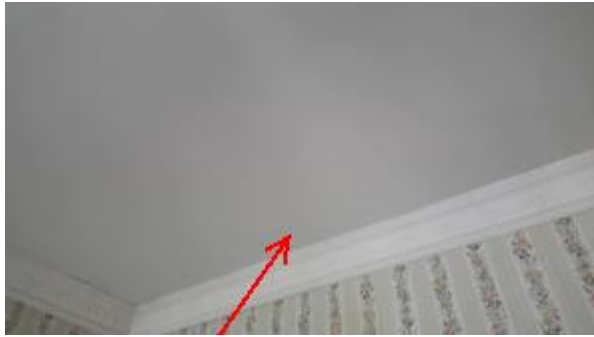
Cracked ceiling

*Fibrous plaster ceiling is typically prone to sagging and cracking and very common for the age of the this building, and may require re-fixing, filling and repainting. (Painter)*

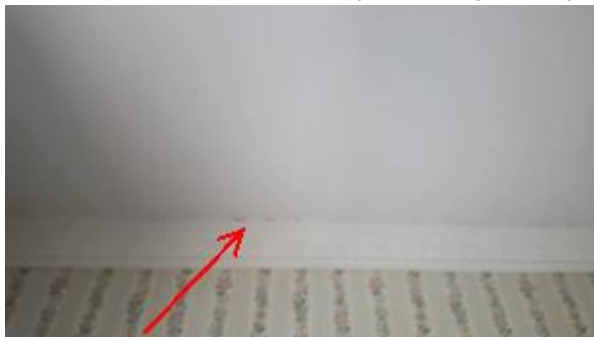
Damaged cornice

*Cornice has cracked and requires filling and repainting. (Painter)*

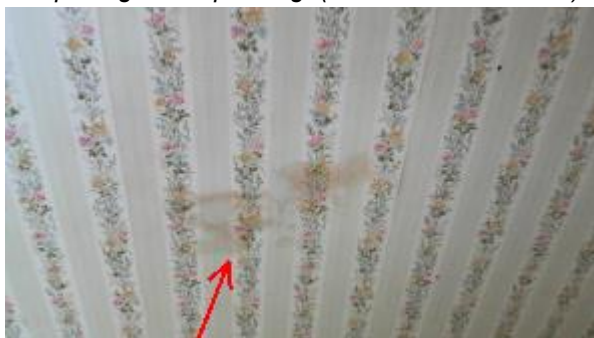
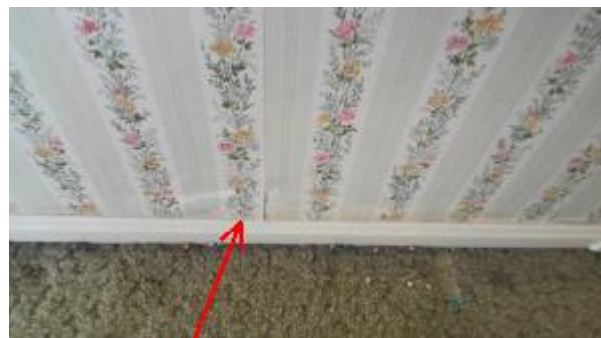
Dampness damage

*High level dampness and minor damage was detected in the lower section of the wall surface, which is common to walls directly adjacent the bathroom particularly when the shower area has been leaking. Once the shower has been repaired and the wall surface should dry out and will only require repairing and repainting. (Plasterer and Painter)*

High level dampness and minor damage was detected in the lower section of the wall surface, which is common to walls directly adjacent the bathroom particularly when the shower area has been leaking. Once the shower has been repaired and the wall surface should dry out and will only require repairing and repainting. (Plasterer and Painter)

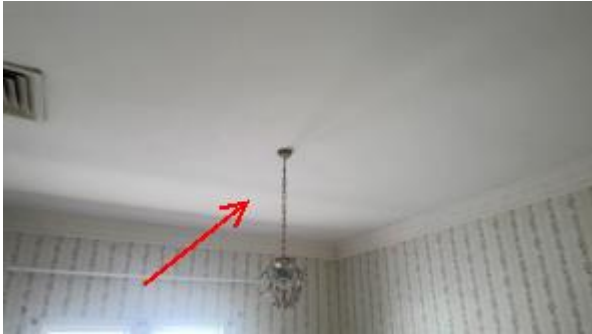
Light not working

*Light was not working at the time of the inspection. (Electrician)*

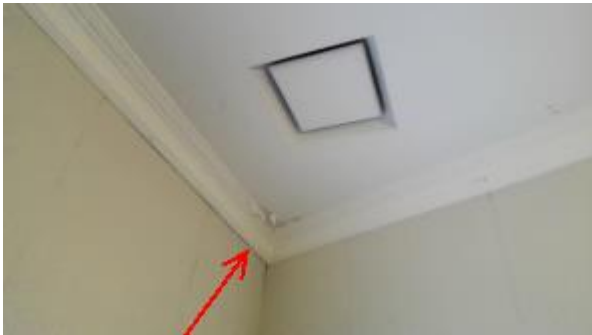
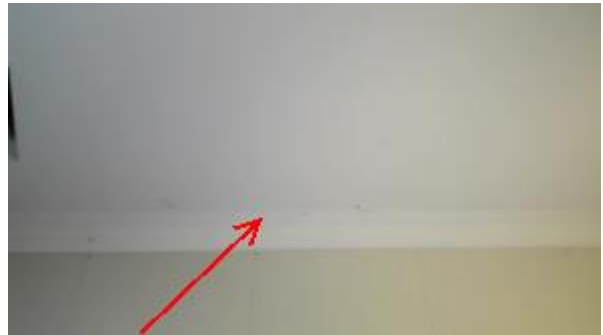
*Paint has flaked from the ceiling, which requires all the loose paint to be scraped off, and the ceiling cleaned, filled and repainted. (Painter)*

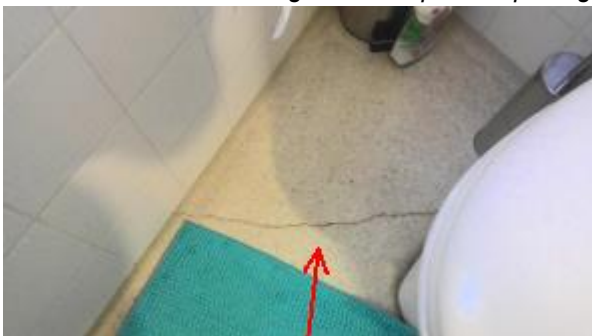
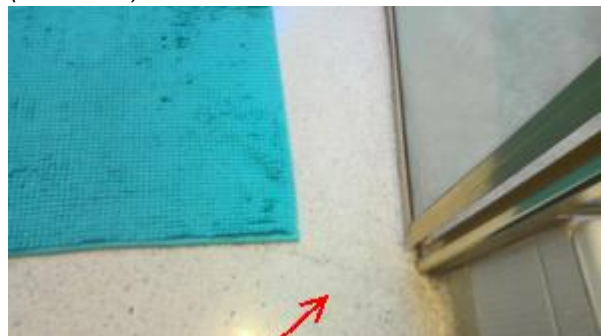
Surface damage

*Terrazzo floor is damaged and requires repairing. (Concreter)*

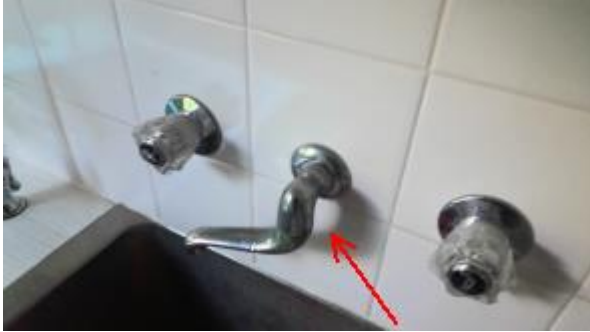
Leaking outlet

*Laundry outlet is leaking and requires replacing. (Plumber)*

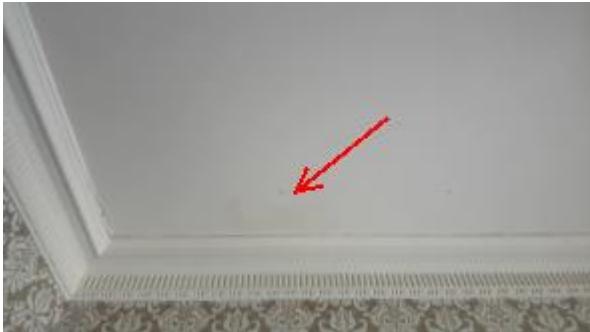
*Water staining is visible in the ceiling, which should be monitored for a possible leak although it appears that the leak may have occurred sometime ago, and when tested there was no moisture present in the ceiling, and requires to be stained sealed and repainted. (Painter)*

Water staining is visible in the ceiling, which should be monitored for a possible leak although it appears that the leak may have occurred sometime ago, and when tested there was no moisture present in the ceiling, and requires to be stained sealed and repainted. (Painter)

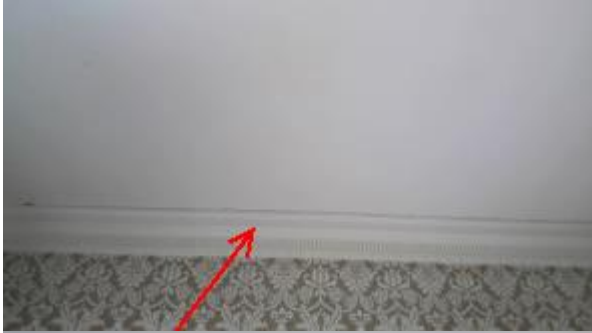
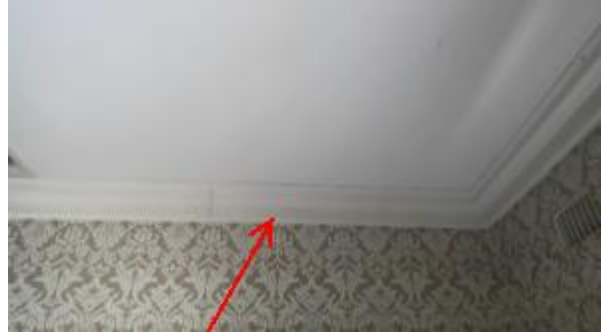
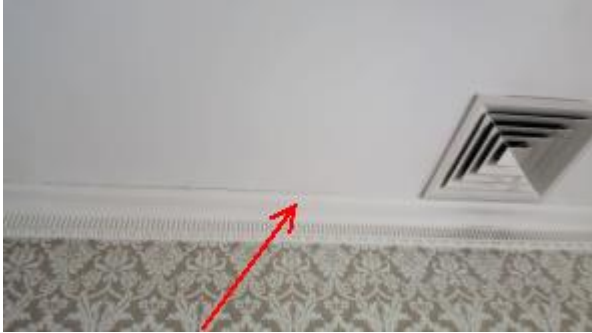
Cornice gapped

*Cornice has gapped from the ceiling surface, which is common and relates to minor movement and requires refilling and repainting. (Painter)*

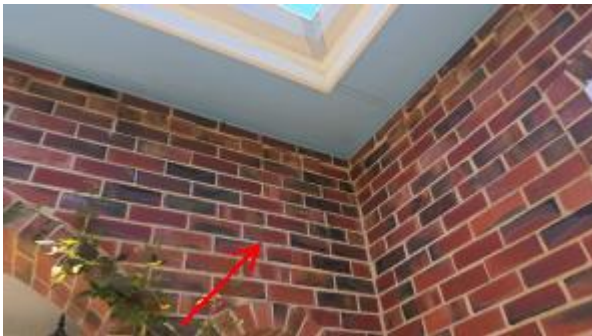
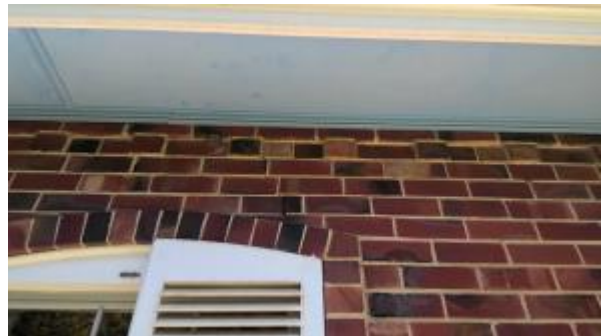
*Cracking has occurred in the wall surface is related to wall and foundation movement, which is also common for the age and construction of the building. The cracking has developed over many years, and now has become an inherent weakness in the wall. The wall will continue to crack at this location and will require continue repairing. (Engineer and Bricklayer)*

Cracking has occurred in the wall surface is related to wall and foundation movement, which is also common for the age and construction of the building. The cracking has developed over many years, and now has become an inherent weakness in the wall. The wall will continue to crack at this location and will require continue repairing. (Engineer and Bricklayer)

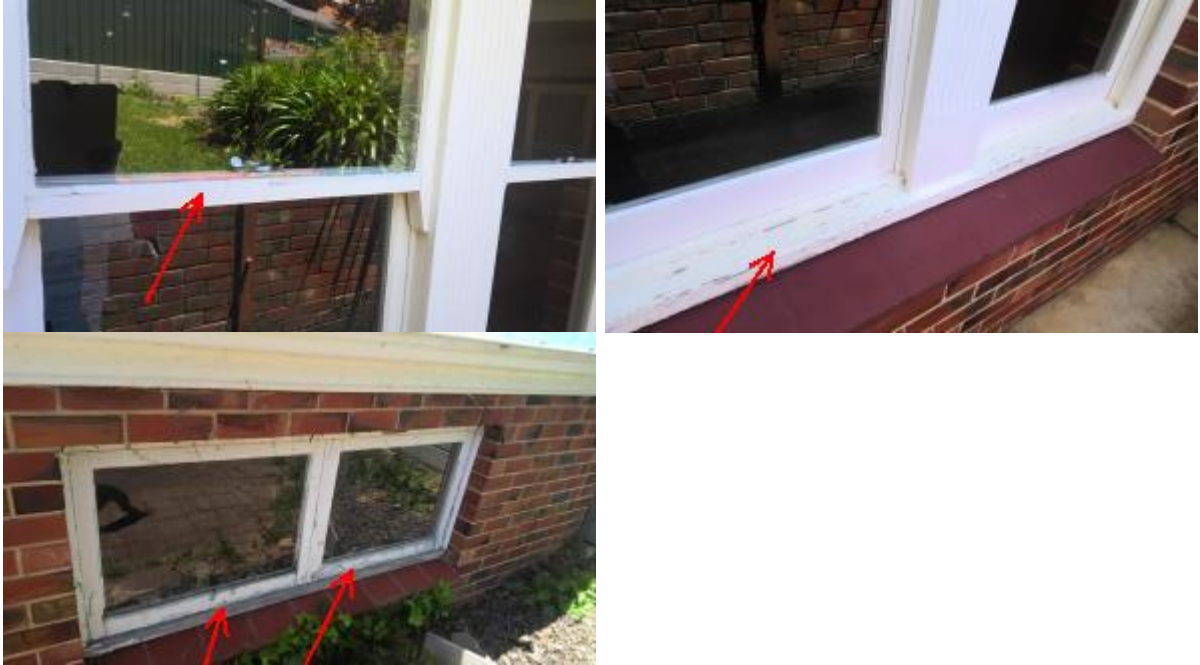
Windows                      Deteriorated window frames and sashes                      Minor Defect                      Type: A

*Window frame and sashes have deteriorated because of lack of maintenance and requires repairing and repainting. (Painter)*

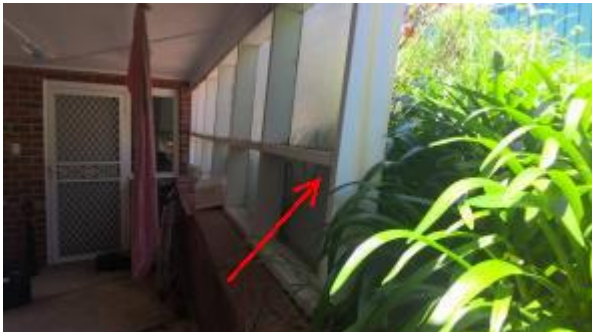
Patio or verandah                      Damaged timber frame                      Minor Defect                      Type: A

*Timber windows on the verandah have moved and decayed and require replacing. (Carpenter)*

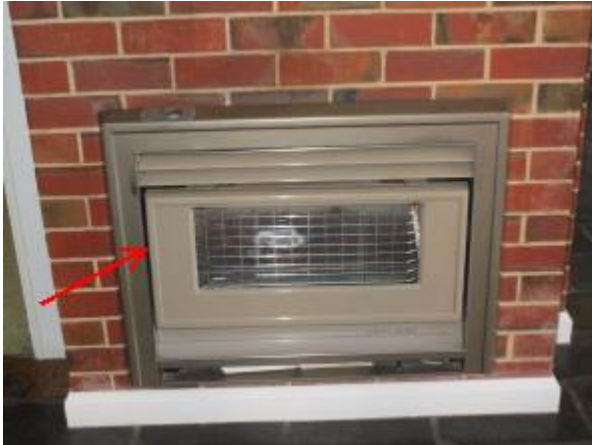
*Gas heater is not working (Gas technician)*

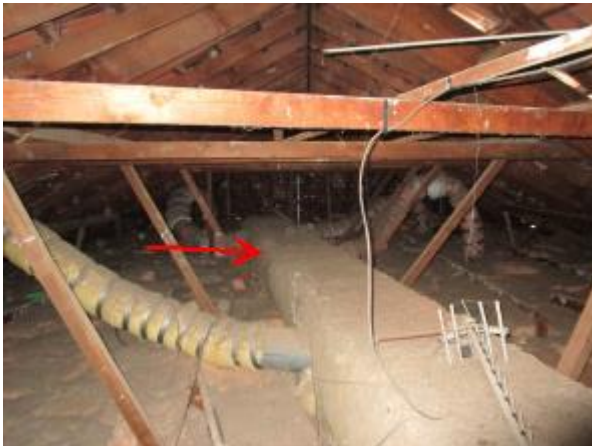
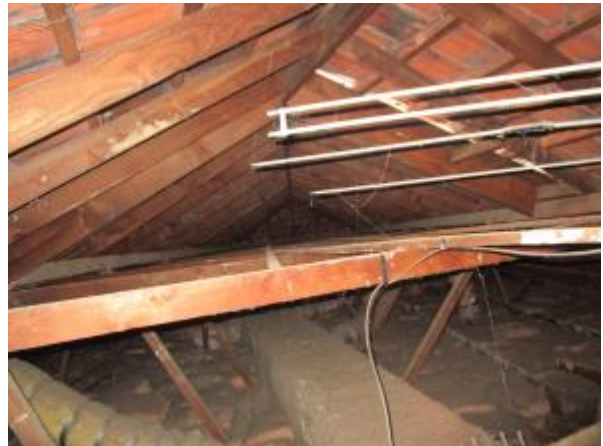
Air conditioner not working

*Evaporative air conditioning unit not working at the time of the inspection. (Air conditioning technician)*

Evaporative air conditioning unit not working at the time of the inspection. (Air conditioning technician)

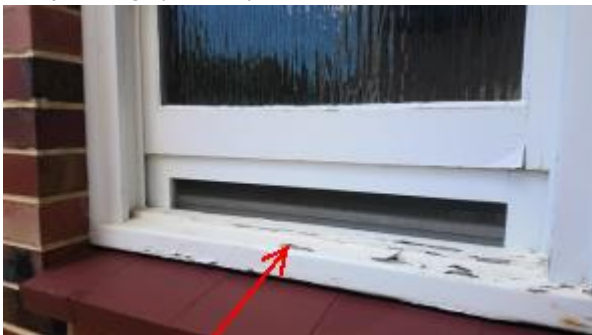
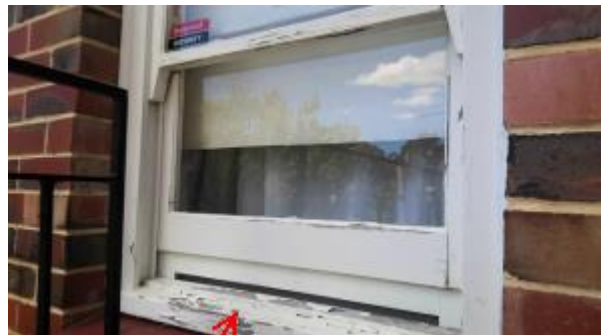
Deteriorated window frames and sashes

*Window frames and sashes deteriorated because of lack of maintenance and requires repairing and repainting. (Painter)*

Window frames and sashes deteriorated because of lack of maintenance and requires repairing and repainting. (Painter)

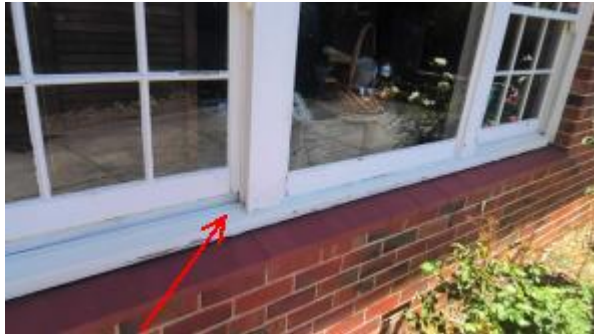
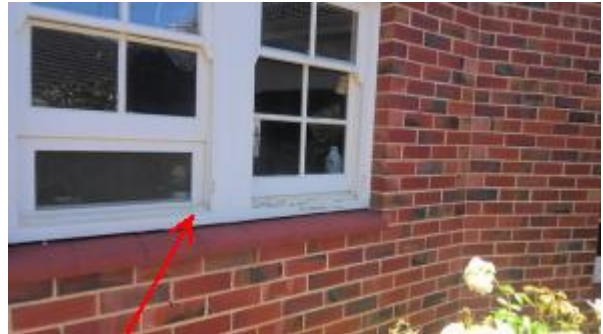
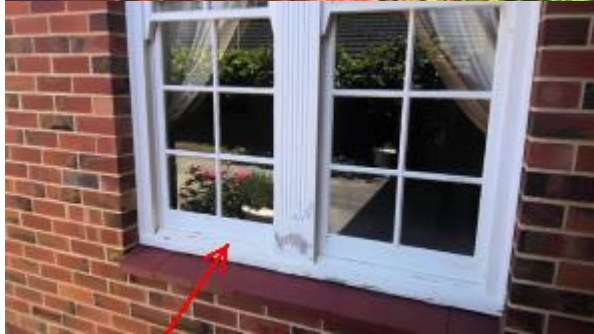
Windows                      Deteriorated window frames and sashes                      Minor Defect                      Type: A

*Window frame and sashes have deteriorated because of lack of maintenance and requires repairing and repainting. (Painter)*

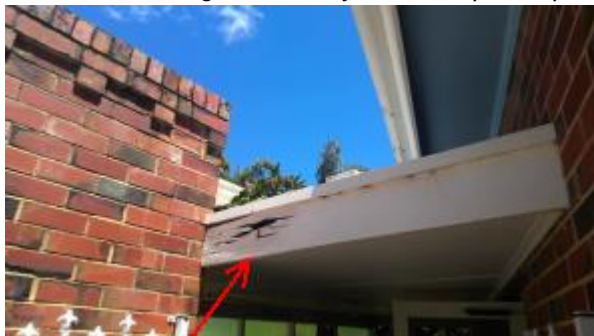
Barge                      Decayed barge                      Minor Defect                      Type: A

*The timber barge has decayed and require replacing. (Carpenter)*

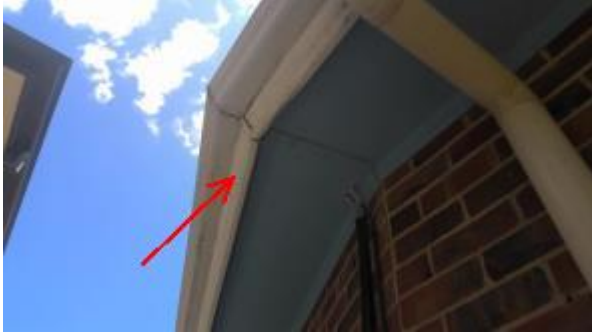
Decayed fascia

*Fascia has decayed from the leaking gutters and requires replacing / repairing. (Carpenter)*

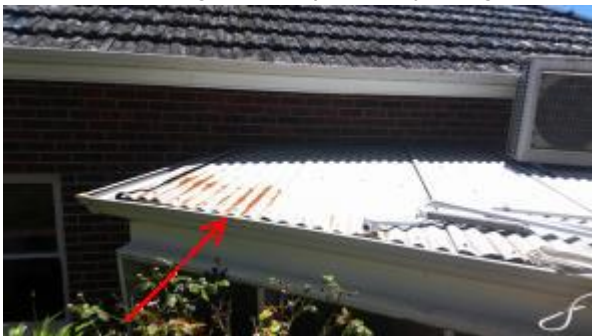
Insufficient pitch for corrugated roof iron

*Roof pitch (or slope) is not appropriate for the use of corrugated iron roof sheets and requires the use of steel decking sheets specifically designed for flat roofs. (Roof plumber)*

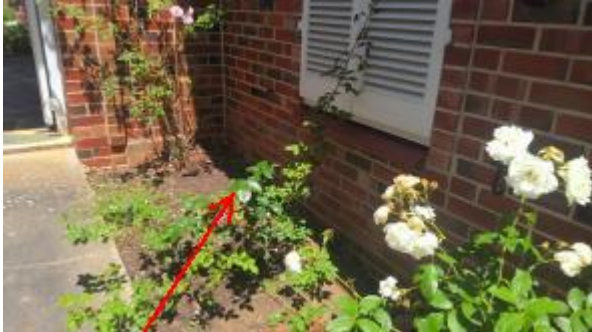
Garden                      Gardens against house a dampness issue                      Minor Defect                      Type: F

*Garden placed against the home can causes dampness issues and should be removed and should be replaced with perimeter paving. (Paving contractor)*

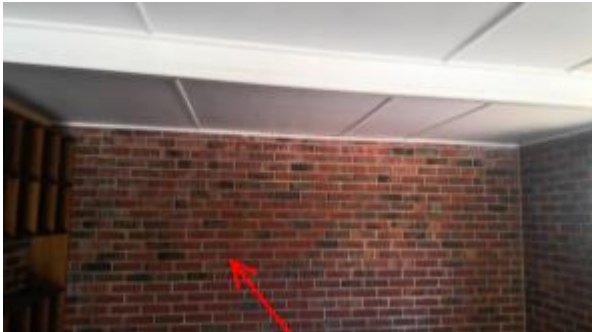
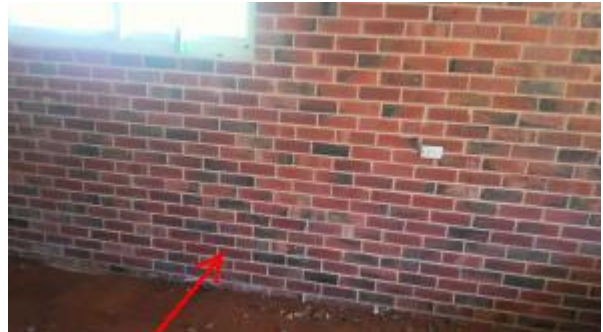
Garage                      Dampness damage                      Further Investigation                      Type: C

*High levels of dampness have been observed in the external wall of the garage which has caused the mortar/ bricks to fret this can be related to the breaching of the damp proof membrane, which is allowing the moisture to rise up the wall. It is recommended that a replacement damp proof membrane or a chemical injection system is to be installed along the garage wall surface. (Salt damp consultant)*

High levels of dampness have been observed in the external wall of the garage which has caused the mortar/ bricks to fret this can be related to the breaching of the damp proof membrane, which is allowing the moisture to rise up the wall. It is recommended that a replacement damp proof membrane or a chemical injection system is to be installed along the garage wall surface. (Salt damp consultant)

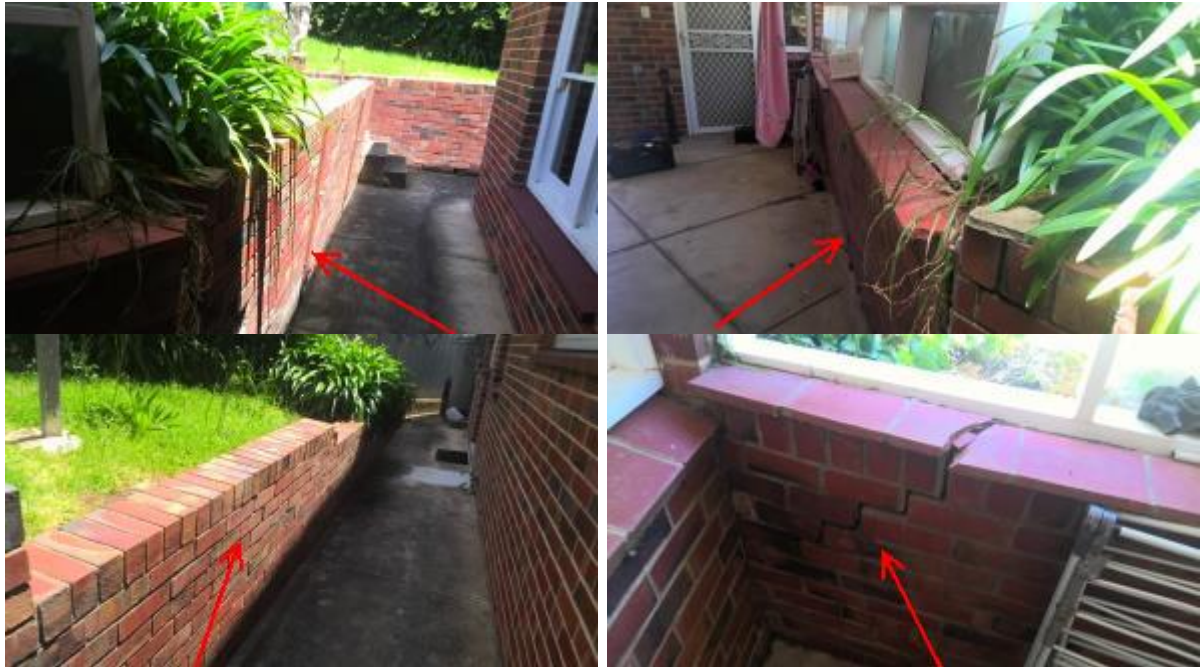
*Retaining wall is leaning and relates to lack of drainage behind the wall, and a build up of water behind the wall can causes hydro-static pressure, causing the wall to lean over, which requires the retaining wall to re-built and incorporating appropriate drainage. (Retaining wall contractor)*

Retaining wall is leaning and relates to lack of drainage behind the wall, and a build up of water behind the wall can causes hydro-static pressure, causing the wall to lean over, which requires the retaining wall to re-built and incorporating appropriate drainage. (Retaining wall contractor)
