Adelaide Building & Property Inspections Pty Ltd

Per-purchase Inspection Report

Property address	9 Poznan Crescent HACKHAM WEST SA 5163
Report prepared for	Paul McGrath ADELAIDE SA 5000
Client's contact details	Mobile 0413 001 211 paulmcgrath@mcgrathgroup.com.au
Real estate agent's details	Name Paul Company McGrath Real Estate
Type of inspection report	Standard Inspection, Defect Only
Persons present	
Weather conditions	Fine
Inspector	Vince Luppino, Bulding Inspector Building Work Contractor BLD 57644

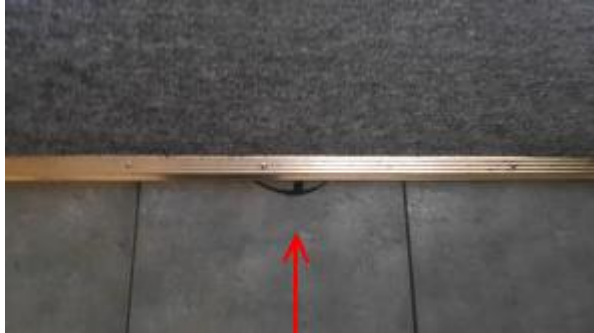
Cracked tiling

Floor tile has cracked and requires replacing. (Tiler)

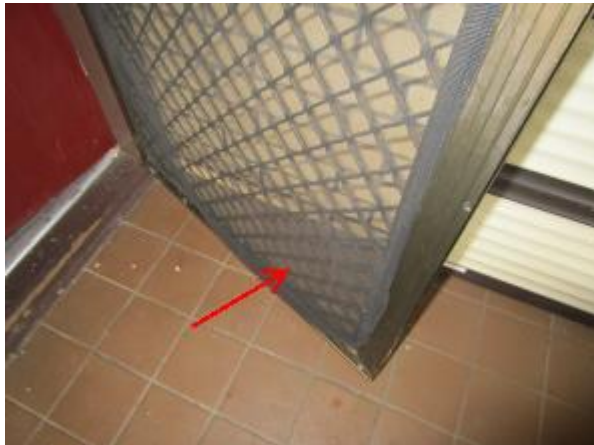
Damaged doors

Fly wire in the screen door is damaged, and requires replacing. (Door manufacturer)

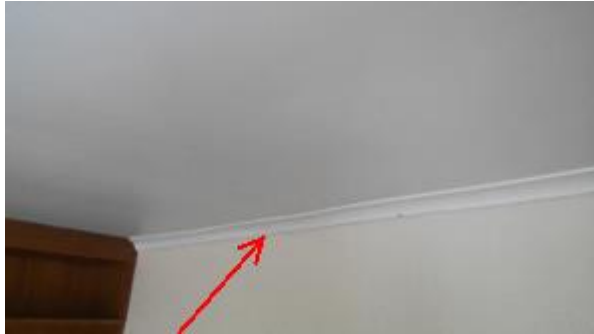
Cornice Damaged cornice Minor Defect Type: A

Cornice has been damaged from the settling of the timber roof trusses, which would usually have occurred shortly after the roof frame was constructed. The roof truss can be carefully lifted and supported on the top of the wall frame, and it is recommended that the existing cornice be removed and a new section of cornice be installed. The new cornice should only be glued to the ceiling and only sealed along the wall surface to allow further movement. (Carpenter, Cornice fixer and Painter)

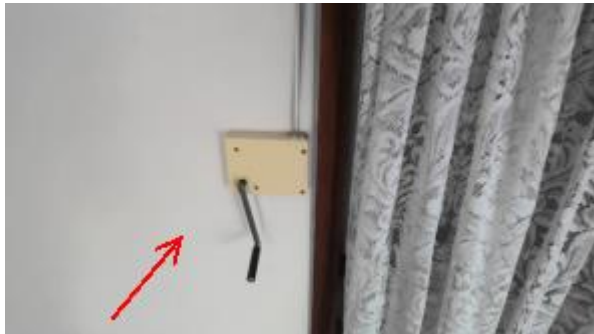
Windows Sash fittings and hardware Minor Defect Type: A

Roller blind is damaged and requires repairing. (Roller blind manufacturer)

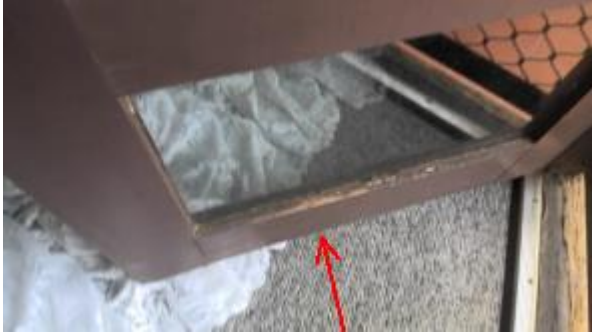
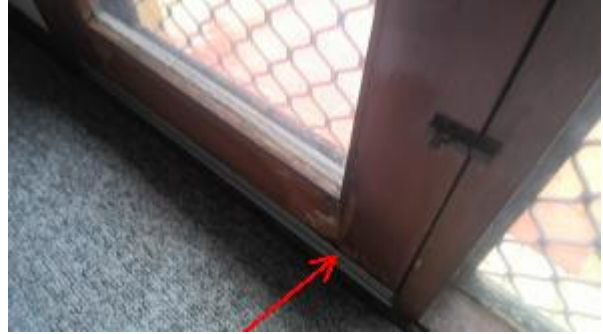
Doors and door frames Damaged doors

Door has been weathered and requires sanding and re-coating. (Painter)

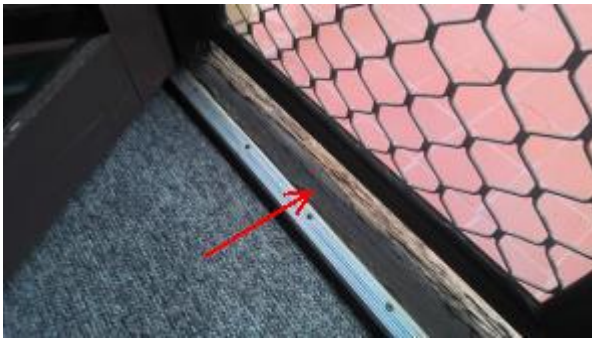
Doors and door frames Damaged door frame

Door frame has been weathered and water damaged and requires repairing. (Carpenter)

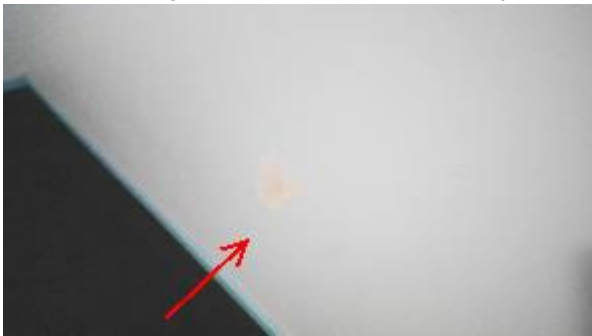
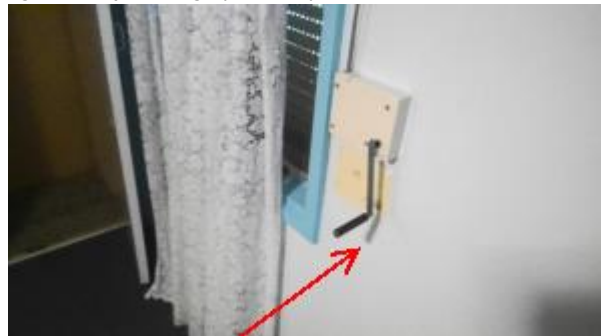
Damaged wall

Minor damage to the wall surface and requires filling and repainting. (Painter)

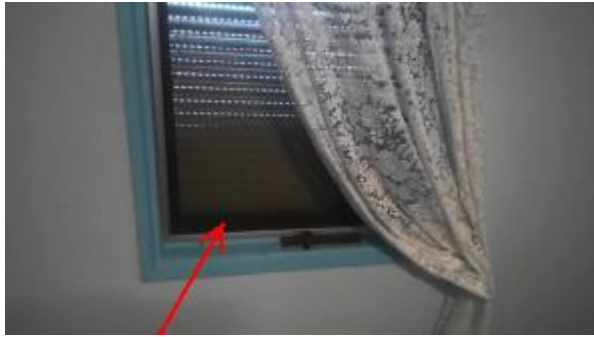
Windows Sash fittings and hardware Minor Defect Type: A
Roller blind is damaged and requires repairing. (Roller blind manufacturer)

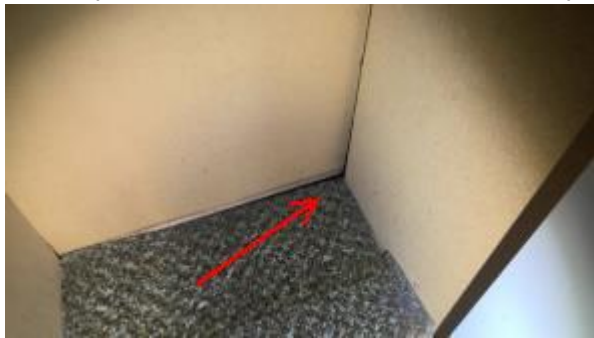
Built in robe/cupboard Damaged internal Minor Defect Type: A
Back panel on the built-in robe is loose and require repairing. (Cabinetmaker)

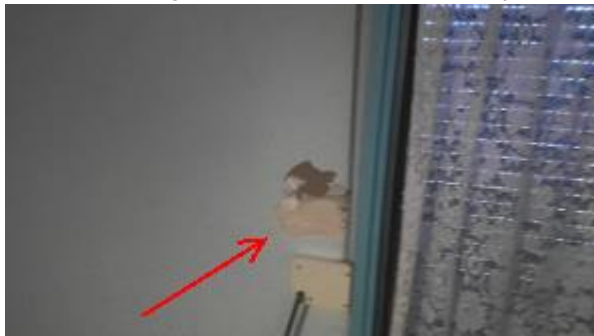
Wall Damaged wall Minor Defect Type: A
Minor damage to the wall surface and requires filling and repainting. (Painter)

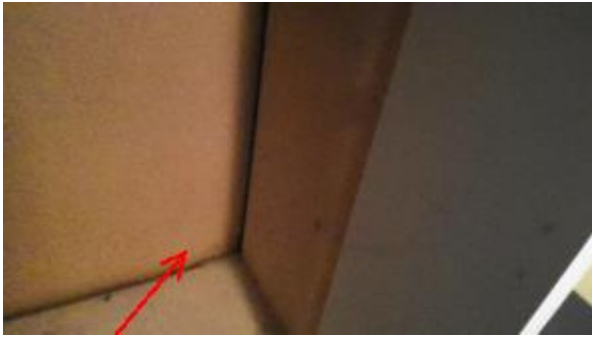
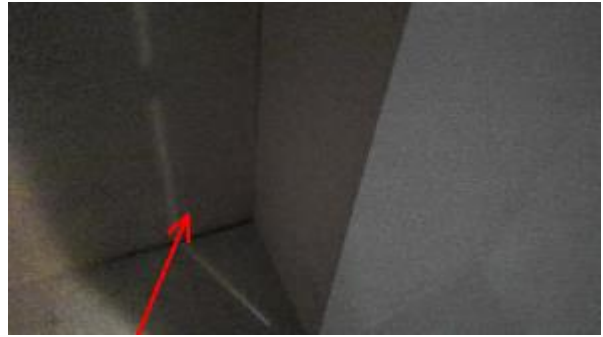
Damaged internals

Back panel on the built-in robes is loose and require repairing. (Cabinetmaker)

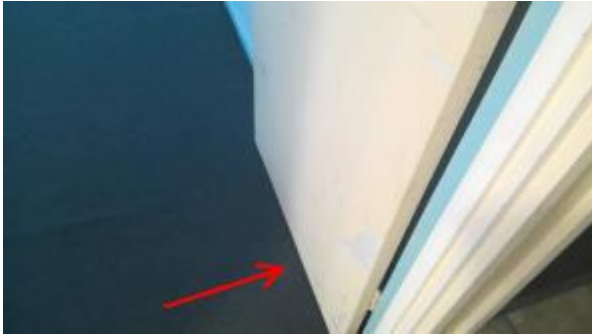
Damaged doors

Door is damaged and requires repainting. (Painter)

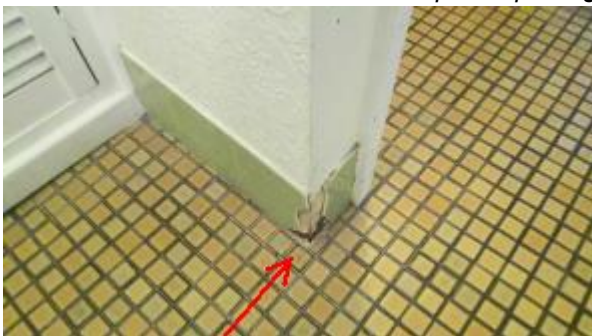
Cracked wall tiles

Two wall tiles have cracked and require replacing. (Tiler)

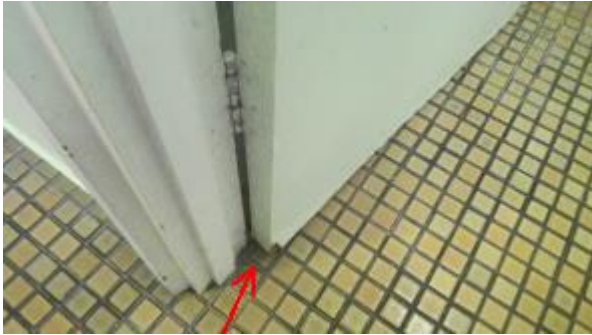
Doors and door frames Damaged doors

Door has been water damaged and requires replacing. (Carpenter)

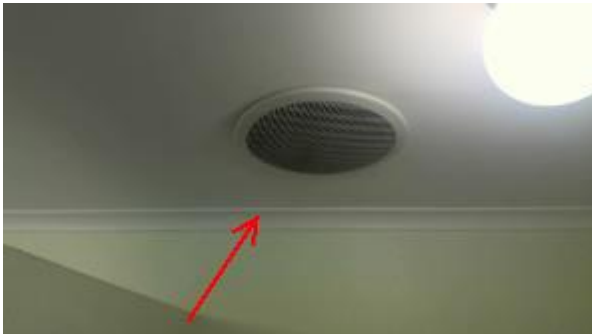
Noisy exhaust fan

Ceiling exhaust fan is noisy and requires replacing. (Electrician)

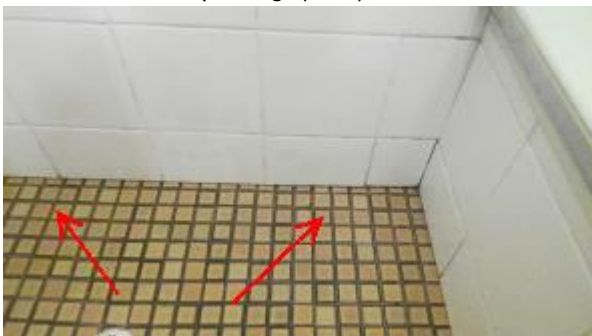
Sealant missing

Sealant between the junctions of wall and floor tiles in the shower area have gapped and requires removal and replacing. (Tiler)

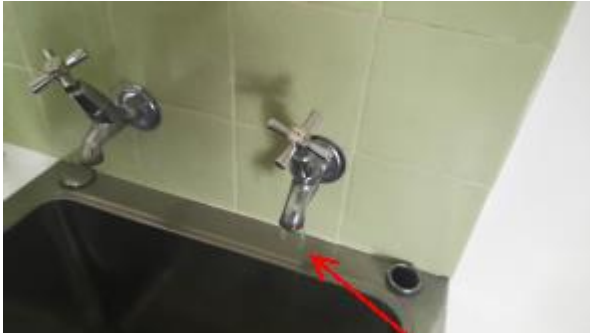
Leaking tap

Laundry cold tap is leaking and requires replacing. (Plumber)

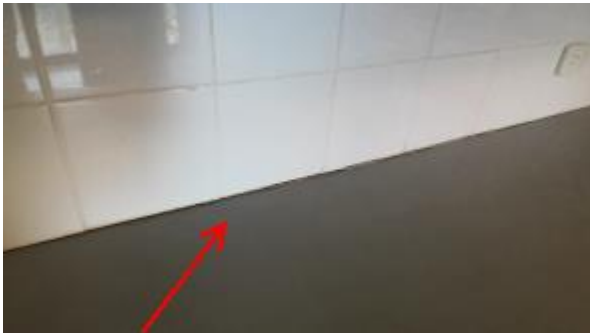
Defective sealant

Sealant between the wall tiles and the bench top has gapped and requires replacing. (Tiler)

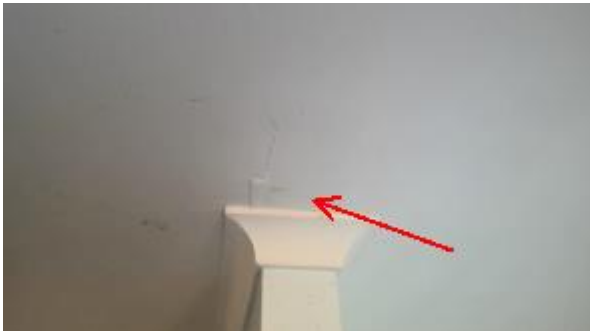
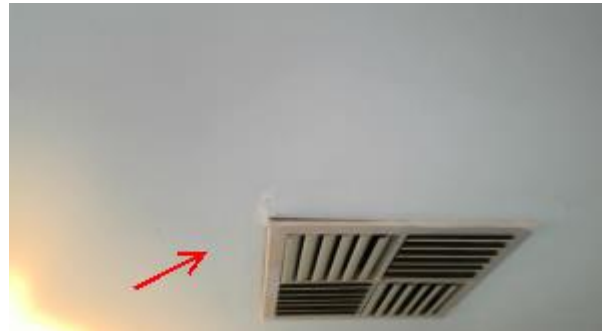
Damage ceiling

Ceiling is damaged and requires filling and repainting. (Painter)

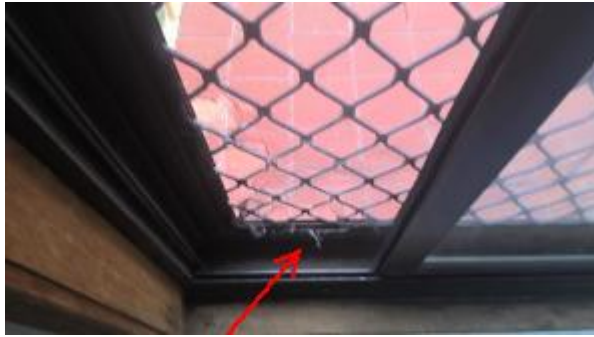
Doors and door frames Damaged doors

Fly wire in the screen door is damaged, and requires replacing. (Door manufacturer)

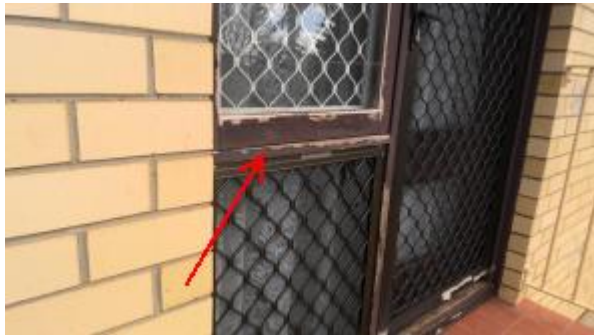
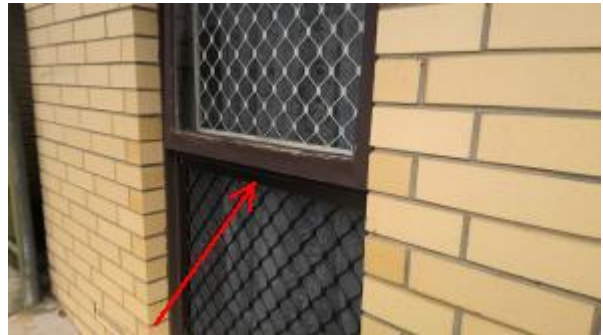
Deteriorated window frames and sashes

Window frames and sashed has deteriorated because of lack of maintenance and requires repairing and repainting. (Painter)

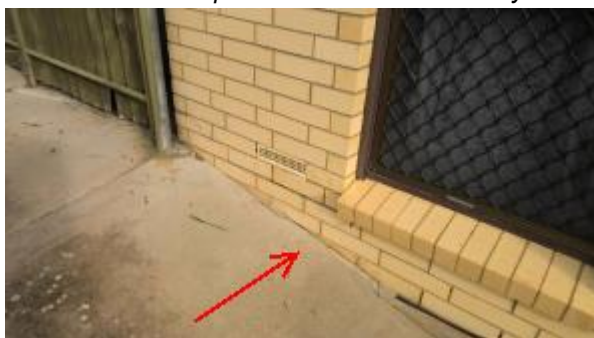
Path breaching damp course

Perimeter paving has been installed too high, which was common for the early years of construction and makes it impossible to detect the entry of termites into the home. (Pest control company)

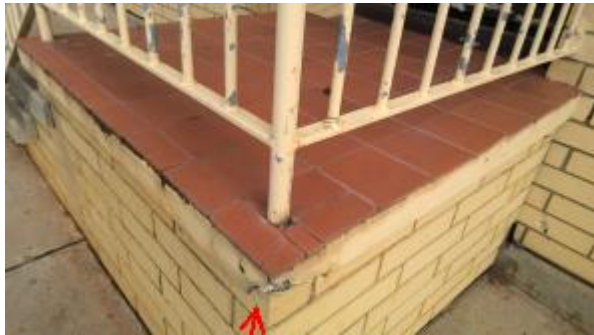
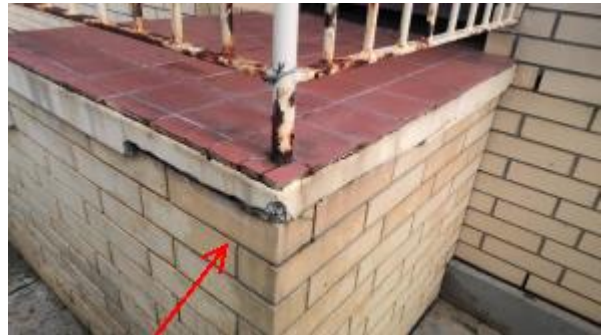
Cracked concrete

Concrete has cracked and requires repairing. (Concreter)

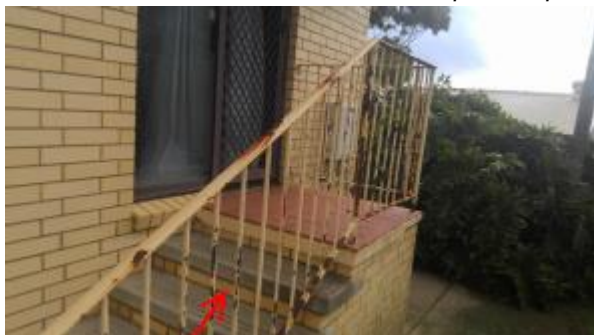
Corroded balustrade

The balustrade has corroded and requires repairing (Painter)

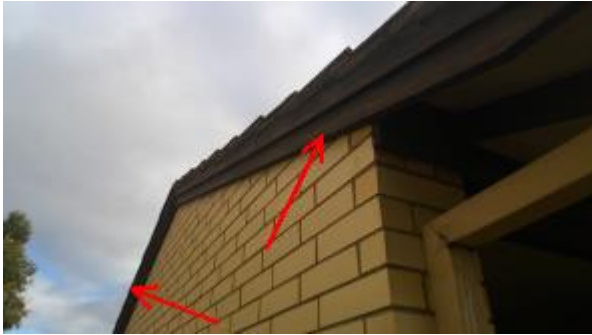
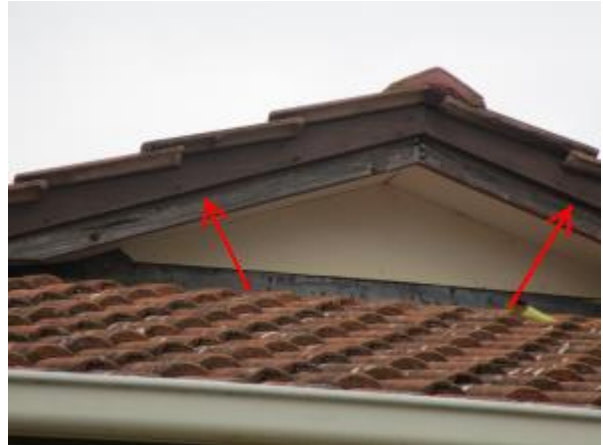
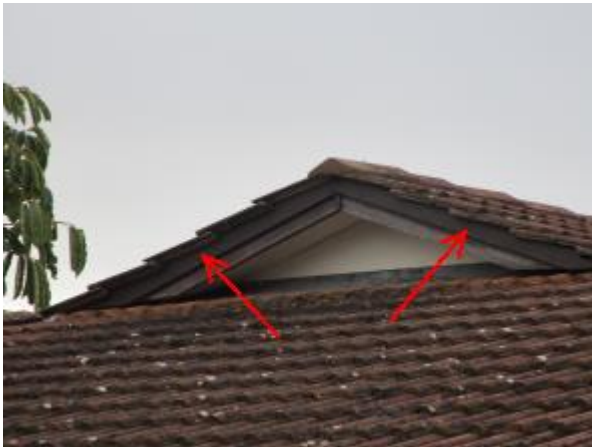
Barge Weathered barge Minor Defect Type: A
The timber barge has weathered and require repairing and repainting. (Painter)

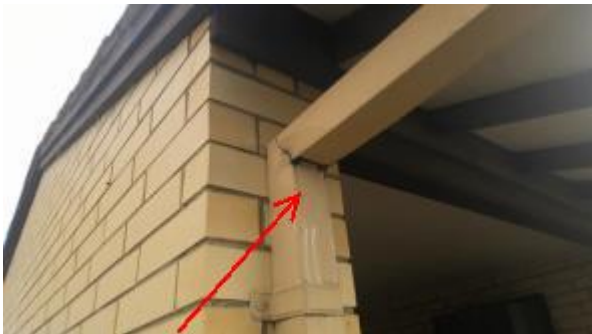
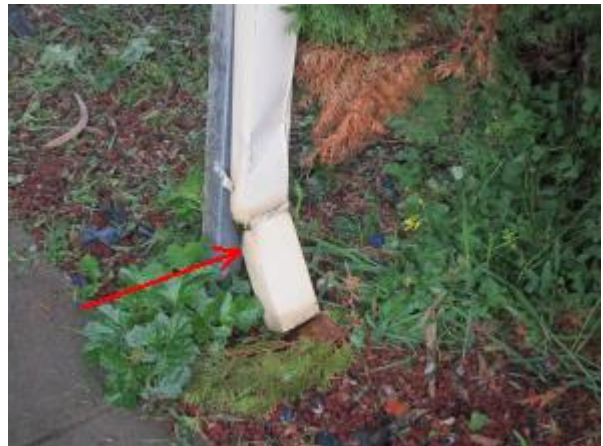
Downpipes Leaking downpipe Minor Defect Type: A
Downpipe is leaking and requires resealing. (Roof plumber)

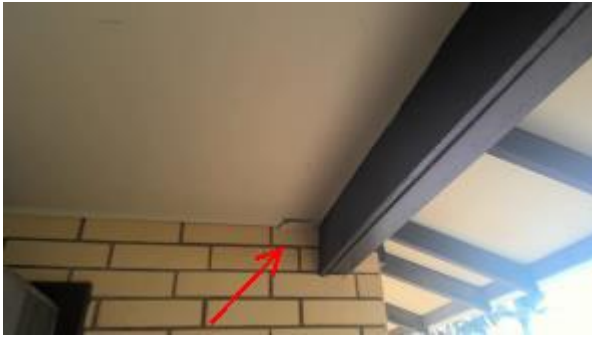
Loose timber trim

Timber trim beneath the eaves is loose and requires re-fixing. (Carpenter)

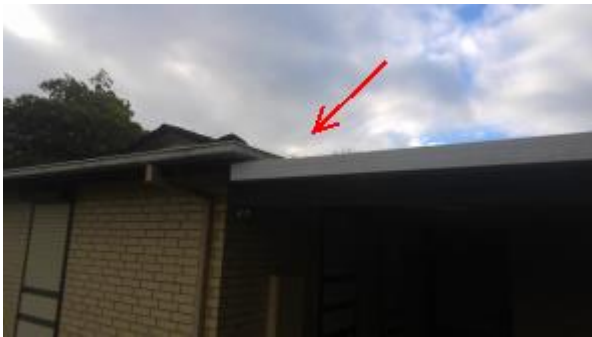
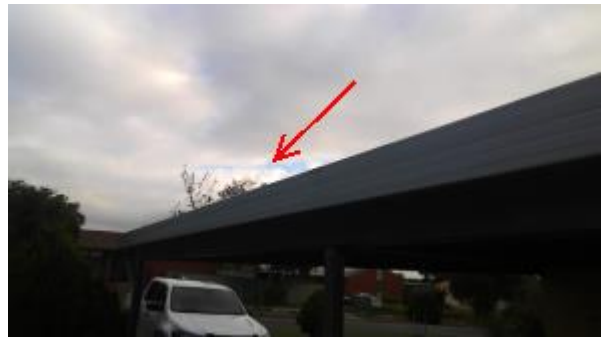
Gutters blocked with leaves and debris

Gutters are blocked with a build-up of leaves and debris and requires regular cleaning. (Gutter cleaning service)

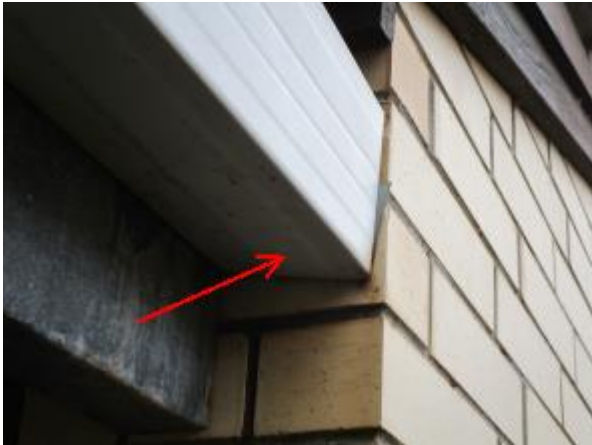
Gutter is leaking

Gutter join is leaking and require resealing. (Roof plumber)

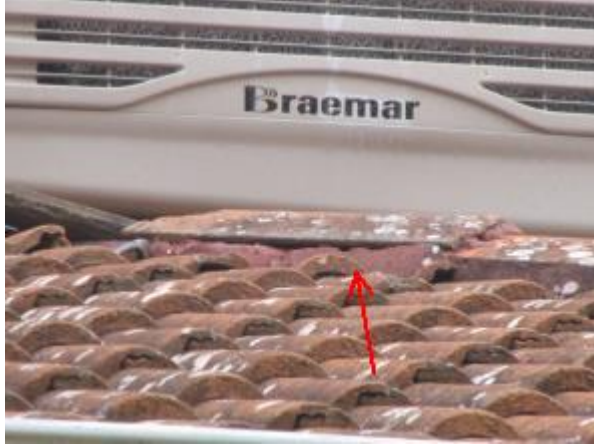
Roof tiles Mortar cracked on the ridge caps Minor Defect Type: A
Mortar on the ridge capping is cracked and loose and requires re-pointing. (Roof tiler)

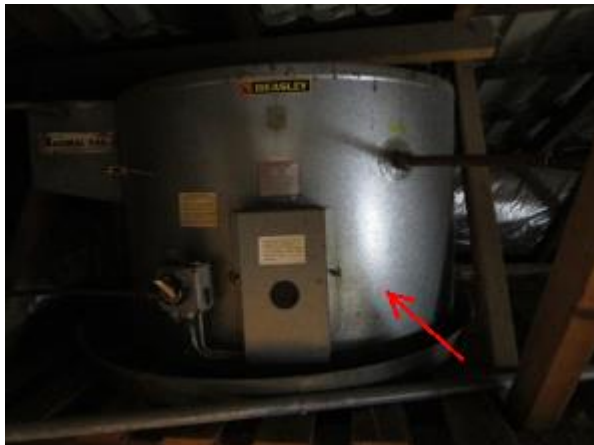
Items in roof space Old hot water service Minor Defect Type: F
Hot water service should be removed. (Plumber)

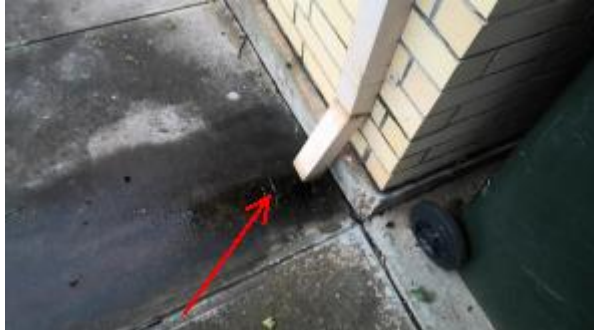
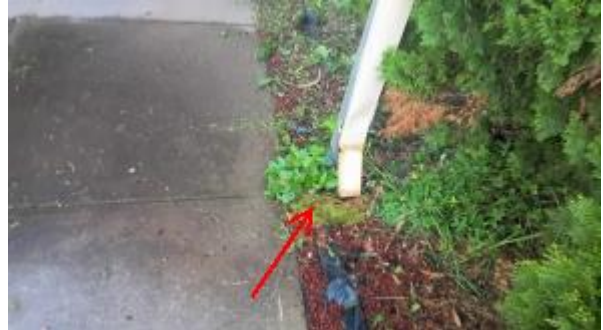
Roof water disposal Roof water discharges to close to the building Minor Defect Type: F

Downpipes are discharging against the building, and should be directed away into a stormwater system removing the roof water away from the building forms good site management and can prevents movement and subsidence of the building. (Plumber)

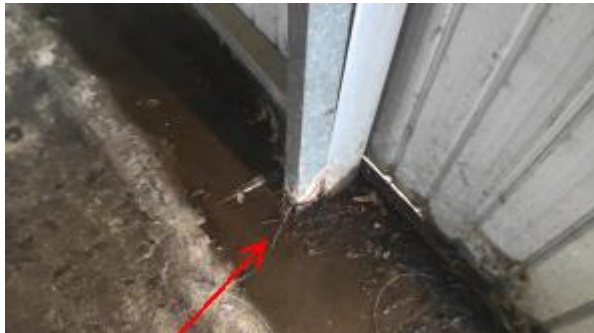
Garage Corroded framing Further Investigation Type: A

External frame work has corroded and requires replacing. (Roof plumber)

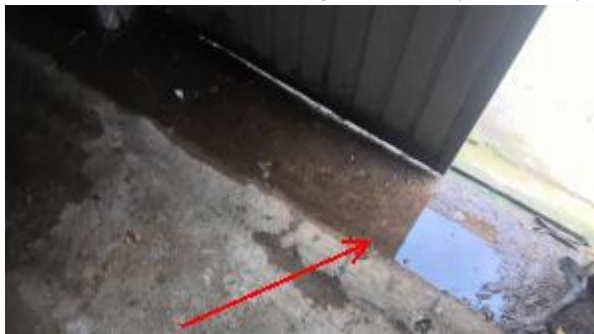
Garage Surface water Minor Defect Type: A

Surface water is not being removed. (Concrete)

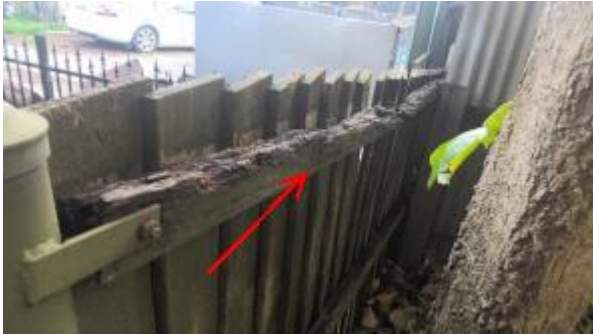
Property fencing Decayed fencing Minor Defect Type: A
Timber rails on the boundary fence have decayed, and require replacing. (Fencing contractor)

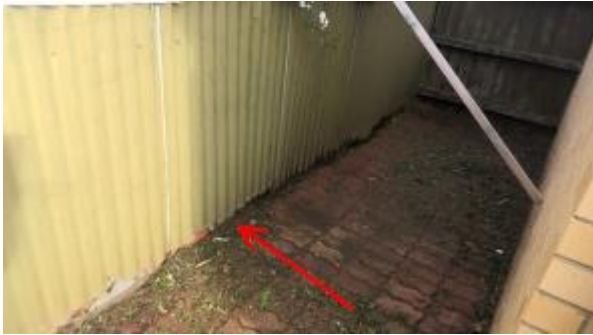
Property fencing Corroded fencing Further Investigation Type: A
Boundary fence has corroded, and requires the corroded sheets replaced. (Fencing contractor)

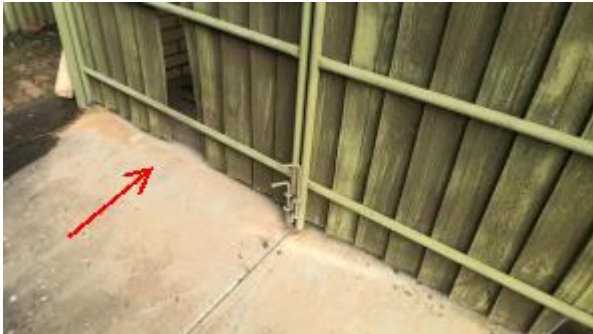
Property fencing Damaged gate Minor Defect Type: A
Gate is damaged and requires repairing. (Fencing contractor)
