Adelaide Building & Property Inspections Pty Ltd

Per-purchase Inspection Report

Property address	2 Manly Circuit WEST LAKES SHORE SA 5020
Report prepared for	The Uniting Church In Australia Property Trust SA ADELAIDE SA 5000
Client's contact details	Mobile
Real estate agent's details	Name Company
Type of inspection report	Standard Inspection, Defect Only
Persons present	Agent's Representative
Weather conditions	Fine
Inspector	Vince Luppino, Bulding Inspector Building Work Contractor BLD 57644

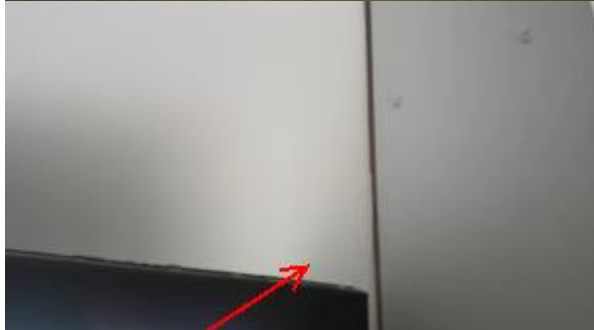
Further Investigation Type: A

Cracking has occurred in the masonry wall adjacent to the window and the door, which is can be common in this type of construction this type of cracking is typical movement that occurs in the walls and the foundations and it can be repaired although the cracking will continue to reoccur overtime. (Engineer and Plasterer)

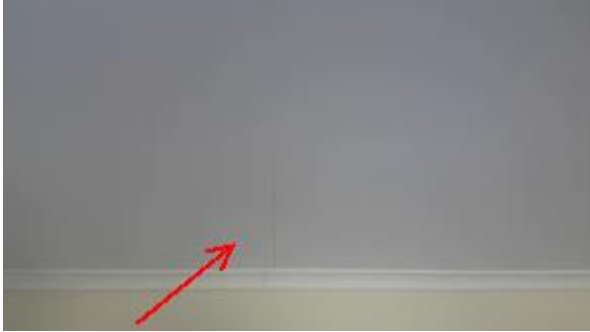
Type: A

Ceiling has split on two sheet joints, which is common and requires filling and repainting. (Painter)
